Mottagare: Kontrollanter, kontrollantelever, klubbar, MC Norden, HL	Datum: 2011-06-02	Bilaga	Blad nr: 1 av 1
		Ärende: Materielmeddelande nr. 1/11	
Fastställd av MK: 2011-06-02	Ersätter:	Utfärdare: SFF Materielkommitté (MK)

SERVICE BULLETIN #20110523

SUBJECT: Inspection of the top diagonal attachment point on all Vector 3 Sport and SE Student Harness/Container Systems.

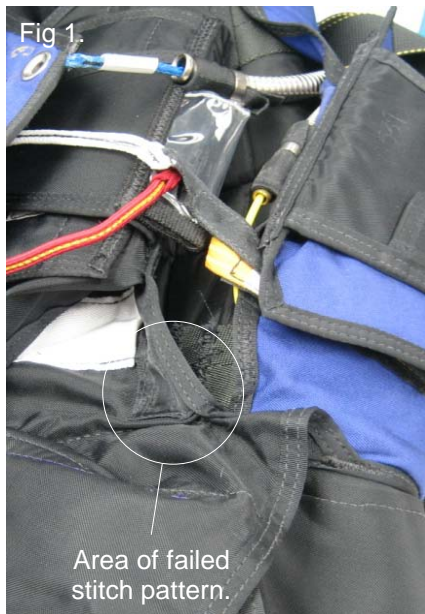
BACKGROUND: It was reported that a student jumper after pulling at a planned altitude of 5000', experienced a very hard opening and broke the upper double zigzag stitching that holds the diagonals in place and tore most of the ring cover off (See Fig1). This allowed the large ring riser attachment to be pulled far away from its normal position, deforming the over the shoulder section of padding and in turn pulled the RSL lanyard releasing the reserve pilot chute.

NOTE: It is unlikely this stitch pattern failed completely on this one jump, but was damaged on other prior jumps and completely failed on this one very hard opening. Further inspection of other Vector SE containers at the same DZ revealed other diagonals with various stages of stitch failure in need of repair.

SERVICE BULLETIN: Before the next jump it is strongly recommended that all jumpers inspect this area for broken stitching. This can easily be done on packed rigs by simply opening the reserve pin cover and riser cover, then work your thumb up under the diagonal to expose the zigzag stitching. Only the top inside section of stitching needs to be inspected (Figure 3). Consult your local rigger if you are unsure or have any questions.

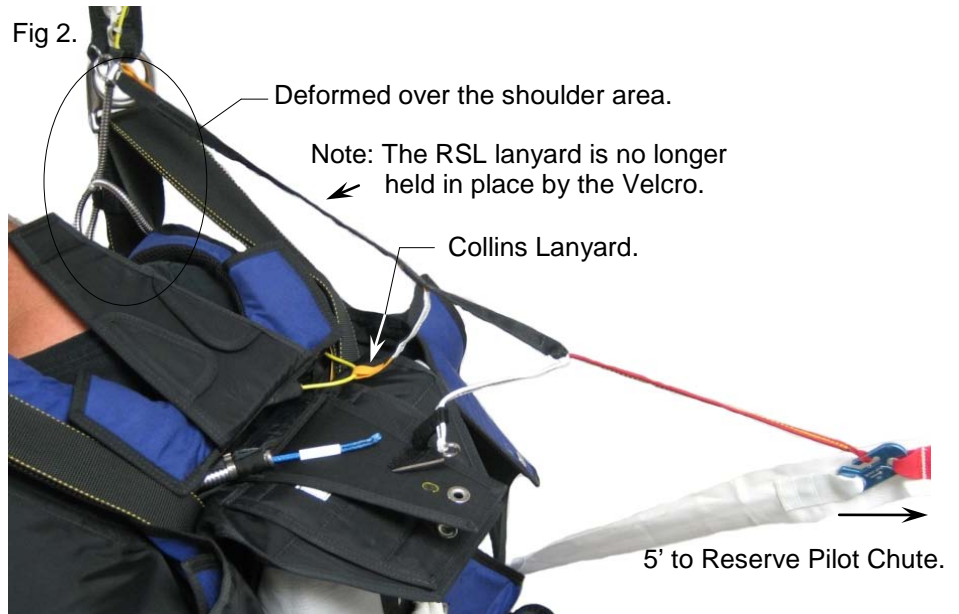
At an altitude of around 4500' the attachment point of the SkyHook and RSL lanyard produced a trailing reserve pilot chute (*preventing a two out scenario*) as witnessed from the ground (See Fig2). At an altitude reported to be between 225' and 250' the student jumper initiated a final approach turn, but due to the deformation of the right shoulder section of the harness, the Collins lanyard released the left riser from this turn input (See Fig2). The student then reacted by immediately pulling the cutaway handle releasing the right riser initiating a SkyHook direct bag deployment. After a very short reserve canopy ride, the student experienced a hard landing in a corn field.

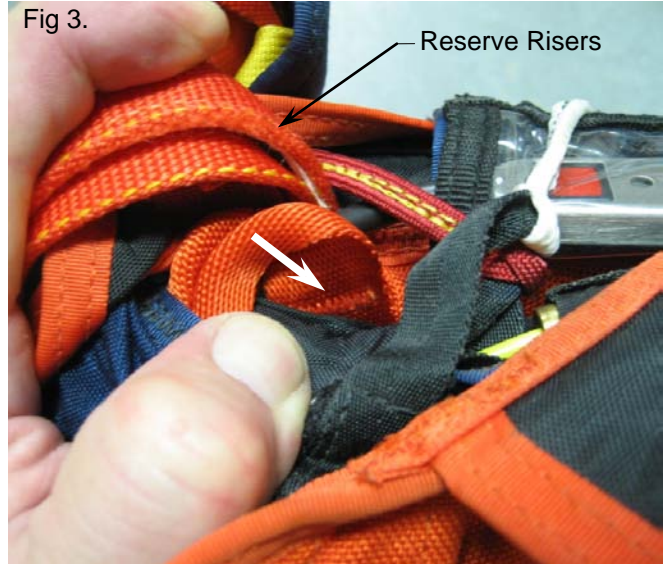
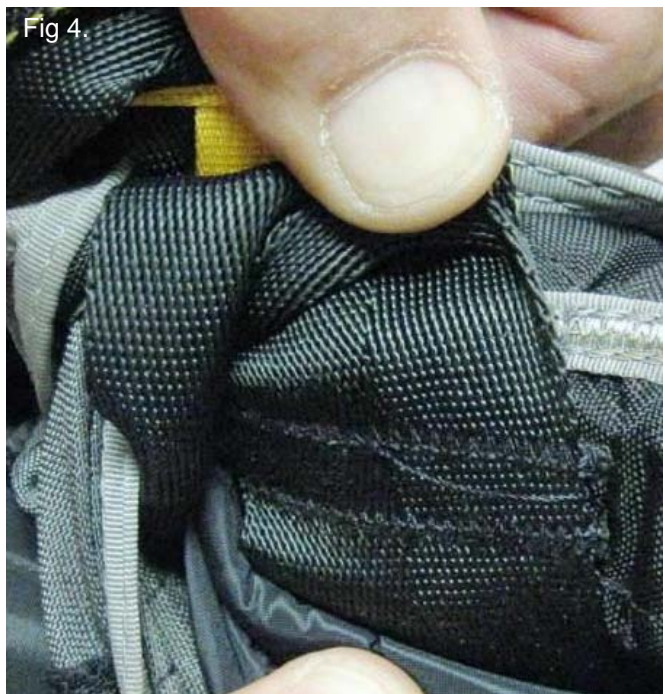
Figures 3 and 4 show examples of undamaged stitch patterns. Undamaged stitch patterns such as these do not require repair.

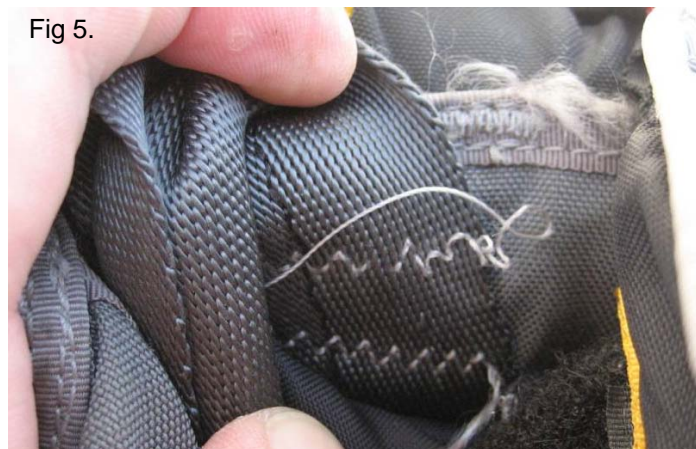
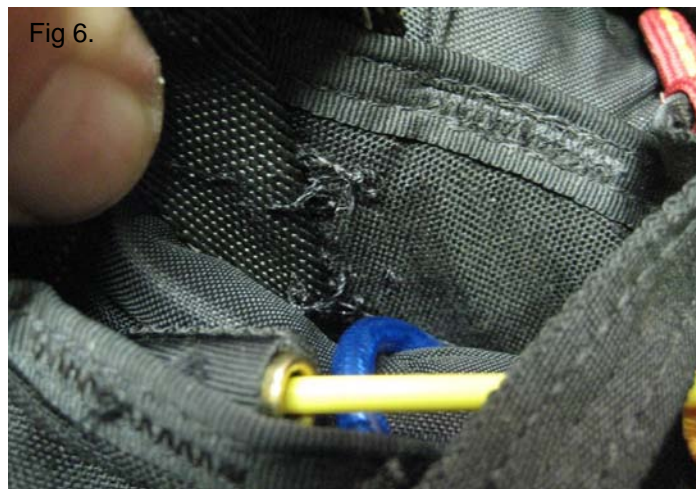
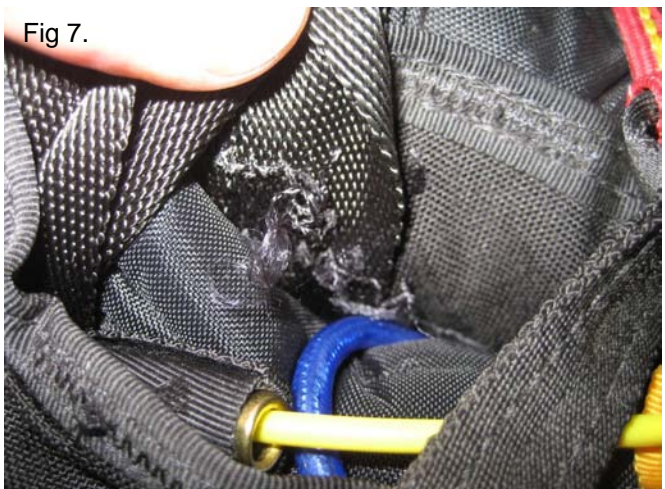
Figures 5, 6 and 7 show example of failing stitch patterns in need of repair.

If the diagonals are in need of repair, riggers in the field are now authorized and requested to make this zigzag repair using “E” shape stitch pattern. This “E” shape zigzag stitch pattern is the same pattern that has been in use on the Sigma Tandem system for some time.
