Mottagare: Kontrollanter, kontrollantelever, CI alla klubbar	Datum: 2019-10-09	BilagService Bulletin	Blad nr: 1 av 1
Fastställt av MK: 2019-10-09		Ersätter:	
Utlärdare: SFF Materielkommitté (MK)		Ärende: Materielvarning nr. 2019/4

Product Service Bulletin

ISSUE DATE: March 30th 2019
Bulletin Number: FB 2019-01
SUBJECT: Reserve pin ripcord assemblies on Firebird EVO Harness Containers
STATUS: **MANDATORY BEFORE NEXT JUMP**
Affected HC: All Firebird EVO HC with Pillow Ripcord assemblies PN 012 built between April 2018-March 2019, Serial numbers BD 001-CB 010
To: All Firebird Dealers and Customers

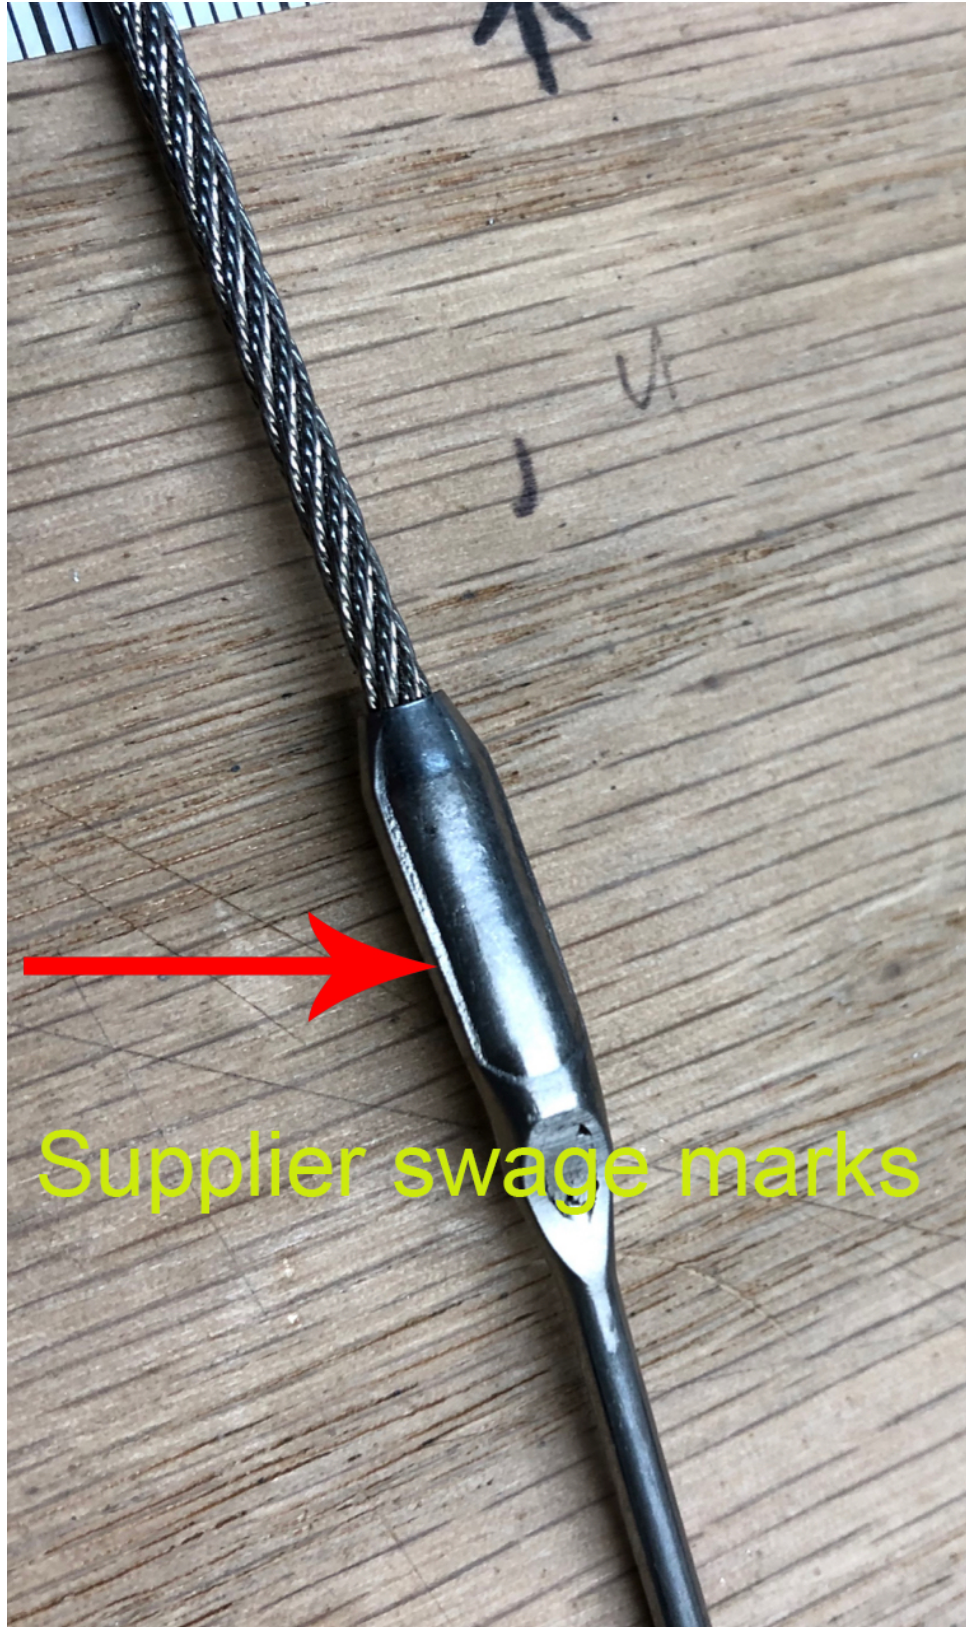
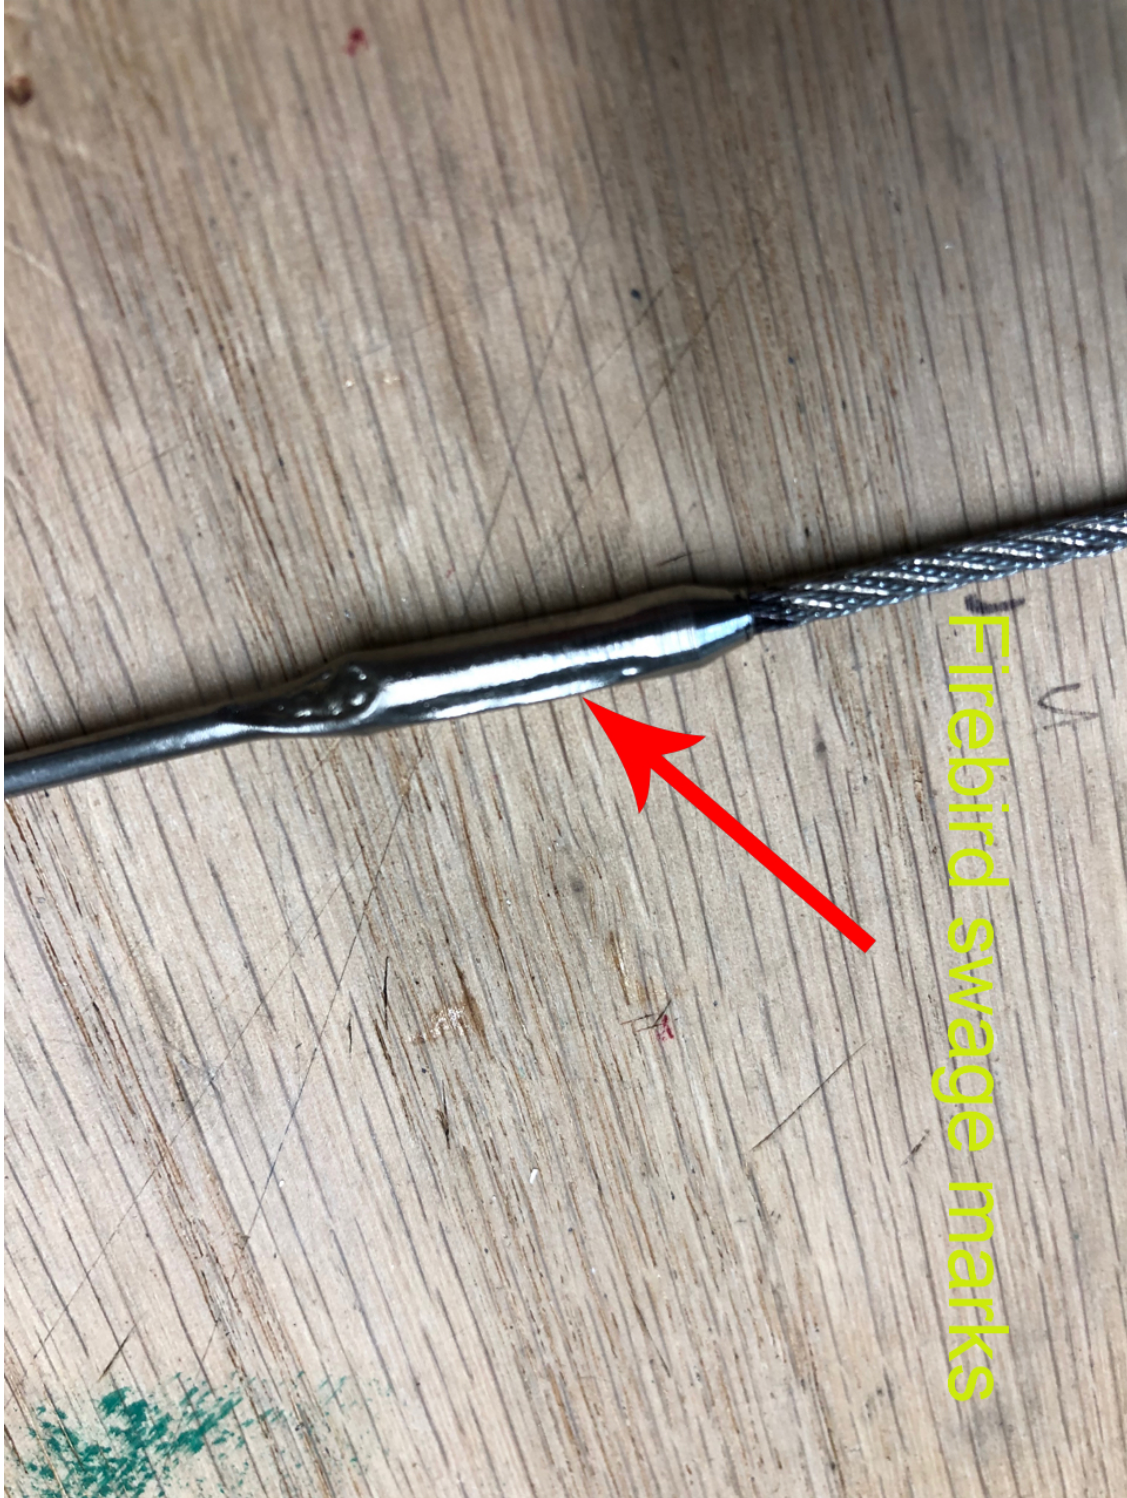
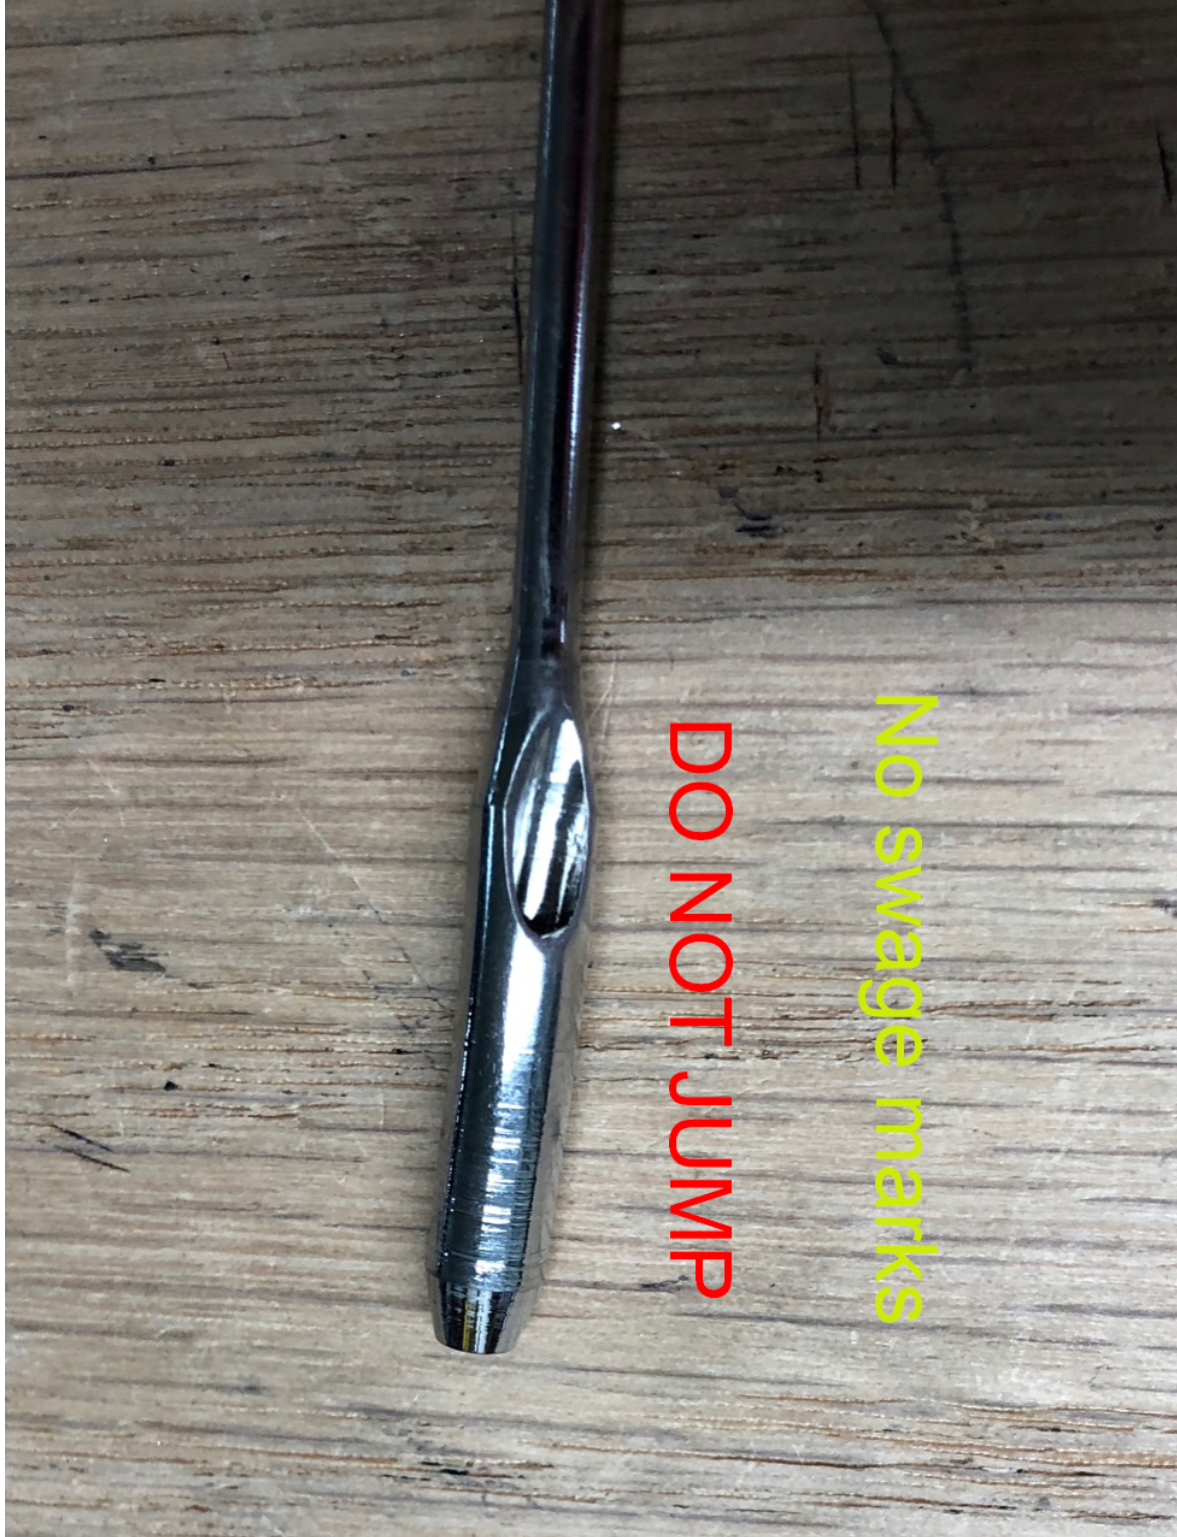
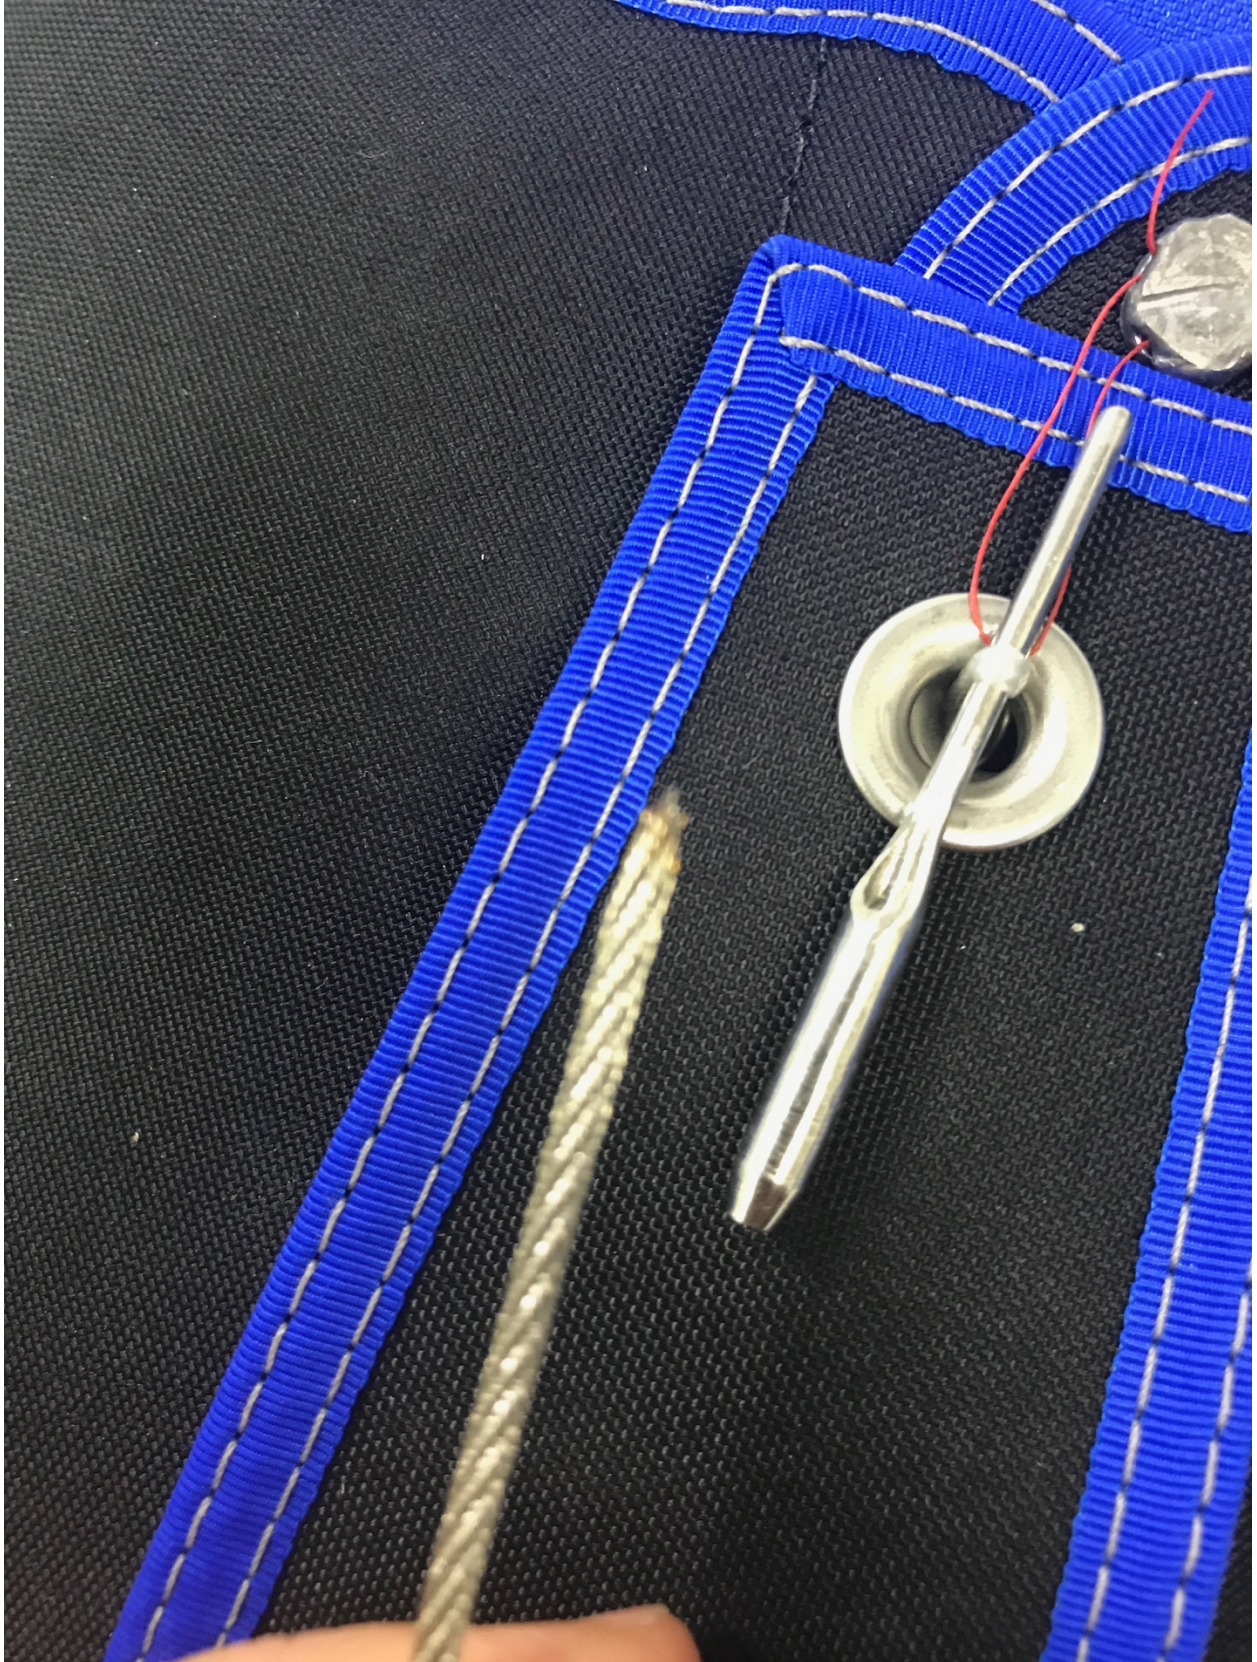
If your HC has a ripcord pillow ripcord assembly installed between SN BD001 and CB010 they have to be visually inspected for swaging marks.

If your reserve pin doesn't have clear swage marks as pictured, DO NOT JUMP until notification and further inspection through Firebird USA LLC.

MANDATORY visually inspection of the pin cable junction by a FAA certified Senior or Master Rigger (or national equivalent) before next jump.

Contact Firebird per phone +1 7473008880 to arrange shipping of a new ripcord at no charge. You can send us pictures per email at usa@flyfirebird.com. Furthermore, the supplier agreed to pull test any ripcord that any customer wants tested.
