AERAZUR 2 rue Maurice Mallet 92130 Issy les Moulineaux Tél. 33 1 41 23 23 23 Fax 33 1 46 48 83 41	<h1>Service Bulletin</h1> <p>Title : Improvement of the Harness/container Titre: amélioration des sacs/harnais biplaces</p>	BS-25-63-34 Date: 31/07/2007 Page 1/8
----------------------------------------------------------------------------------------------------------------------	----------------------------------------------------------------------------------------------------------------------------------	-------------------------------------------------

Block 1	<u>Technical Background</u>	
a)	Applicability	: <u>Dual harness/containers</u> : 740-1 (ATOM TANDEM) and MMS 740-2 manufactured before 2002 as presented in page 2.

b)	Reason	: Packing procedure not correctly applied and improvement of the center flap design.
c)	Description	: During a tandem jump a main canopy line has been caught under the center flap in the configuration: <ul style="list-style-type: none"> ➤ Improperly packing process: The elastic band was not inserted through the lateral grommets of the POD. In this configuration, at the extraction of the POD out of the container, some lines can be extracted from the ela

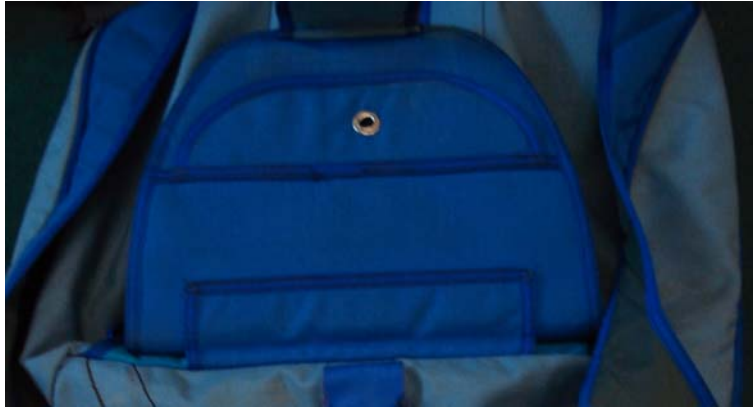
First generation

This Service Bulletin concerns these two designs:

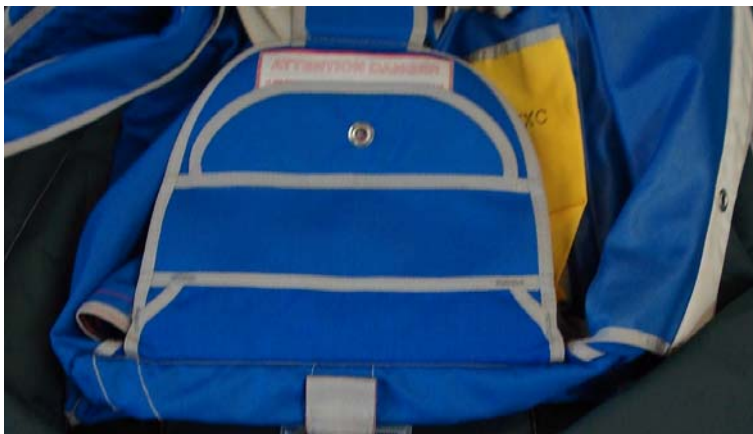
This design is not concerned by this Service Bulletin :

Please consider the orientation of the inner flap between the second and the last generation

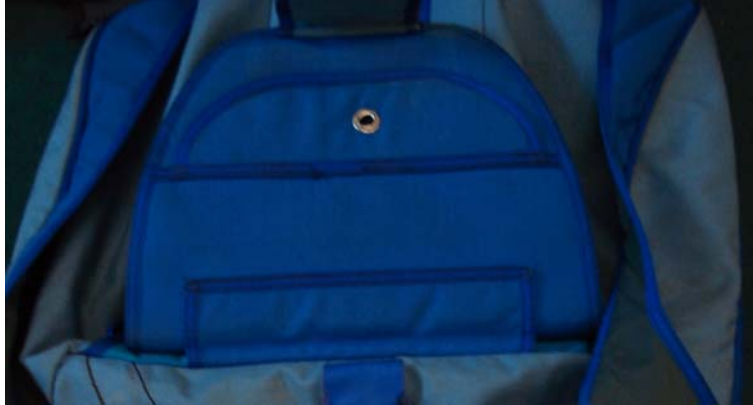
Première génération

Ce Bulletin Service concerne ces deux définitions:

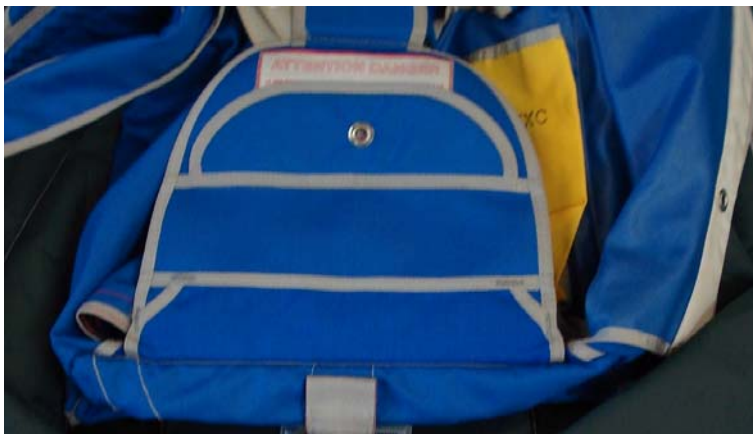
Cette définition n'est pas concernée par ce Bulletin Service :

Attention à porter sur l'orientation du volet de protection entre la seconde et dernière génération.
