# SERVICE BULLETIN SPSB009

SUBJECT: SUPPLIER/VENDOR RECALL OF PS70104 HOUSINGS (METAL FLEX HOISING INC)

STATUS: MANDATORY INSPECTION AND REPLACEMENT OF RECALLED HOUSINGS

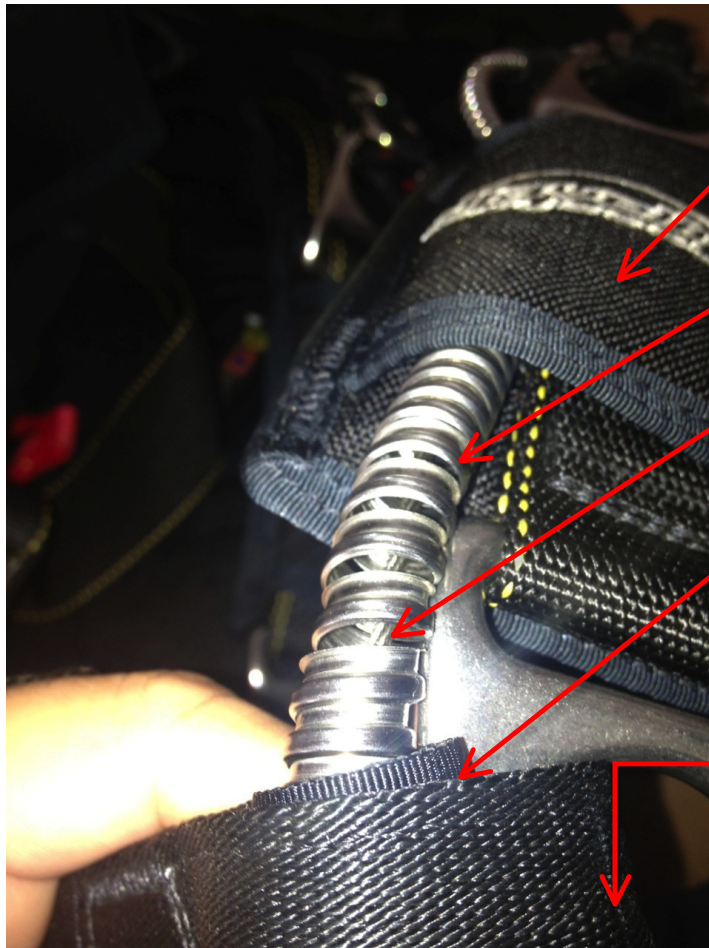
**WEARERS LEFT SIDE:**

RING COVER

RESERVE RIPCORD HOUSING (LOWER END)

SEPERATED HOUSING (FOR REFERNCE)

CHEST STRAP BUFFER

CHEST STRAP

If the serial number is listed in the above table, inspect the available exposed reserve ripcord housing. Locate the lower end of the housing, which is clamped to the Main Lift Web, just above the reserve ripcord pocket. Inspect the exposed length of housing from the clamp upwards; ensure that the coil has not separated/unraveled. Be sure to inspect the section that is routed through the chest strap.

A. **HOUSING FOUND TO BE INTACT (GOOD):** The rig may continue to be jumped with periodic monitoring until the next repack cycle or earlier elective replacement. However this housing must be replaced at the next repack cycle. See <http://www.sunpath.com/support/HousingReplacement.pdf> for instructions for your rigger to complete the replacement of the housing.

B. HOUSING FOUND TO BE SEPERATED/UNRAVELLED (BAD): The housing must be replaced before the next jump by a certificated senior or master parachute rigger (or foreign equal) or the manufacturer. See <http://www.sunpath.com/support/HousingReplacement.pdf> for instructions for your rigger to complete the replacement of the housing or instructions to send your system back to the manufacturer.
