Mottagare: Kontrollanter, kontrollantelever, klubbar, MC Norden, HL	Datum: 2015-06-25	BilagService Bulletin	Blad nr: 1 av 1
Fastställt av MK: 2015-06-25		Ersätter:	
Arende: Materielvarning nr. 1/15		Utfärdare: SFF Materielkommitté (MK)

PRODUCT SERVICE BULLETIN 2015-01

SUBJECT: EXCESSIVE URETHANE COATING ON SPECTRA RESERVE RIPCORD

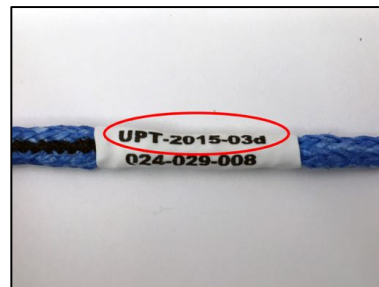
*Locate the white sleeve on the Spectra reserve ripcord.
The top line will read the lot # as "UPT-201X-XXX"*

LOT # UPT- 2015-04 AND LATER ARE NOT SUBJECT TO THIS PSB.
