Mottagare: Kontrollanter, kontrollantelever, klubbar, MC Norden, HL		Datum: 2007-02-27	BilagService Bulletin	Blad nr: 1 av 1
		Ärende: Materielvarning nr. 2/07		
Fastställt av MK: 2007-02-27	Ersätter:	Utfärdare: SFF Materielkommitté (MK)

Product Service Bulletin

Bulletin Number: **PSB-3**

Subject: Vigil Cutters with Plastic Insert

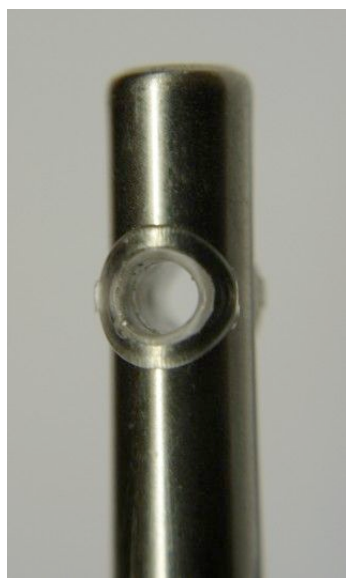
OK

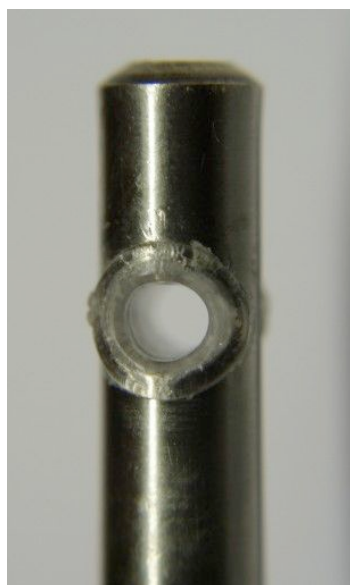
OK

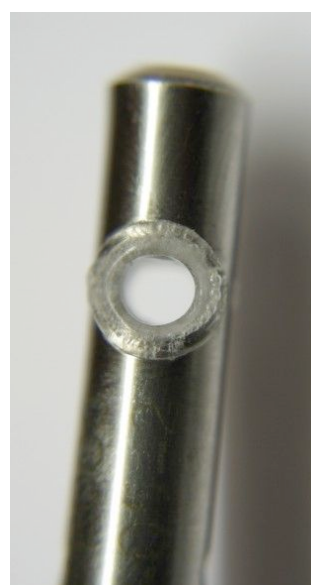
OK

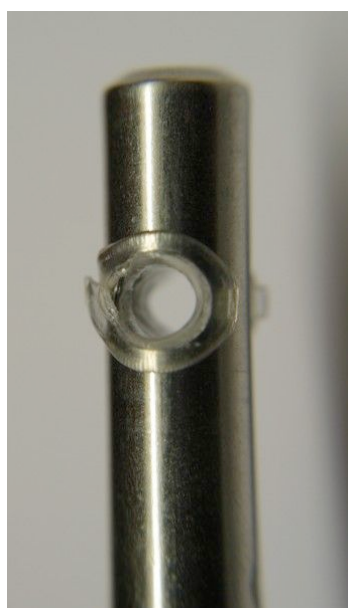
Cutters have been found in the field with damaged plastic inserts that have in turn damaged the closing loops. If the damage is severe enough, it is possible for the reserve-closing loop to sustain damage.

NOT OK

If damage is found, please contact your dealer, Vigil AAD Brussels or Vigil USA for advice and/or eventual cutter replacement.

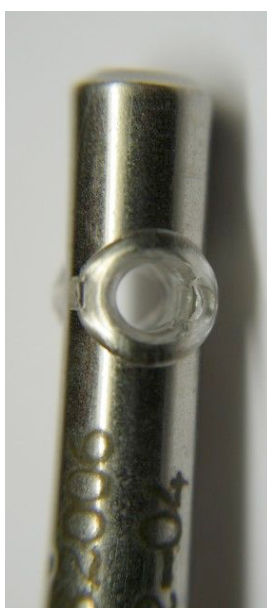
NOT OK

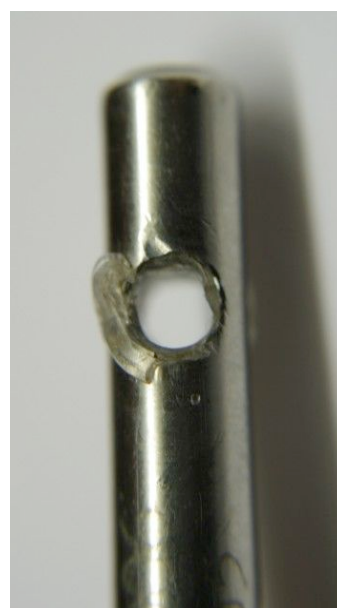
NOT OK

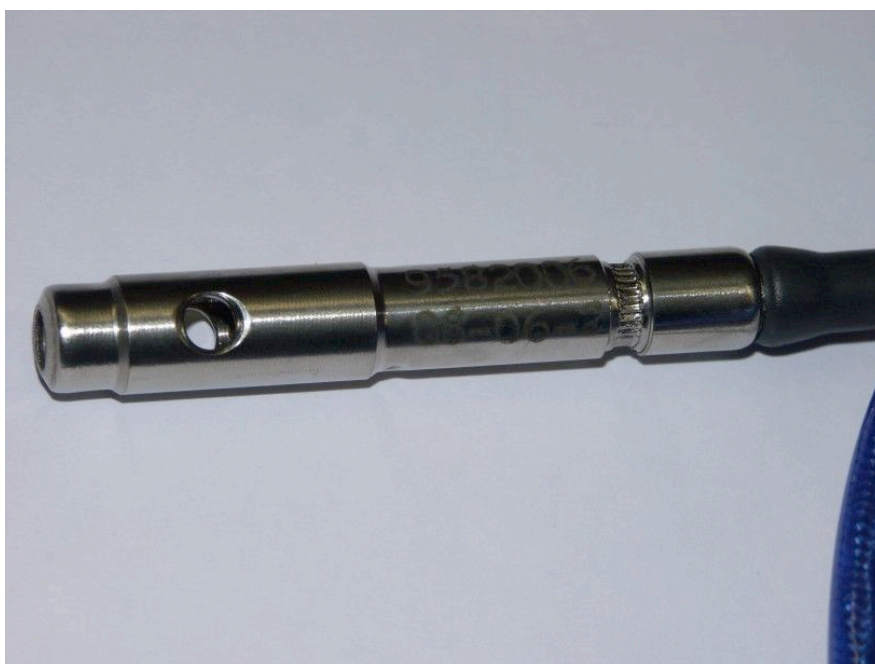
New Full Inox Replacement Cutter (From August 2006)

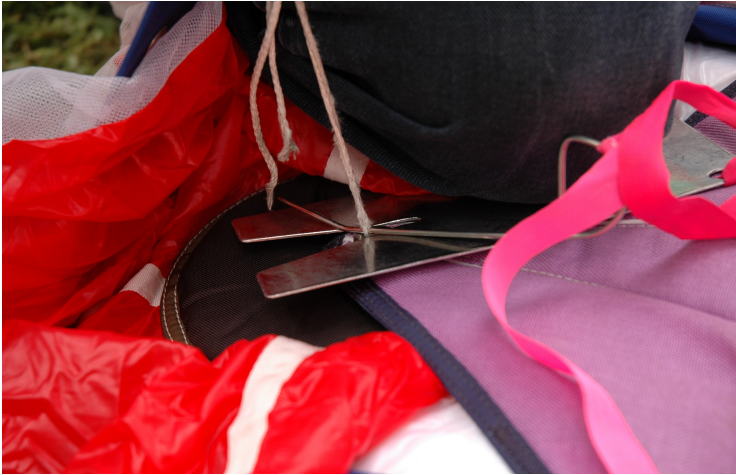
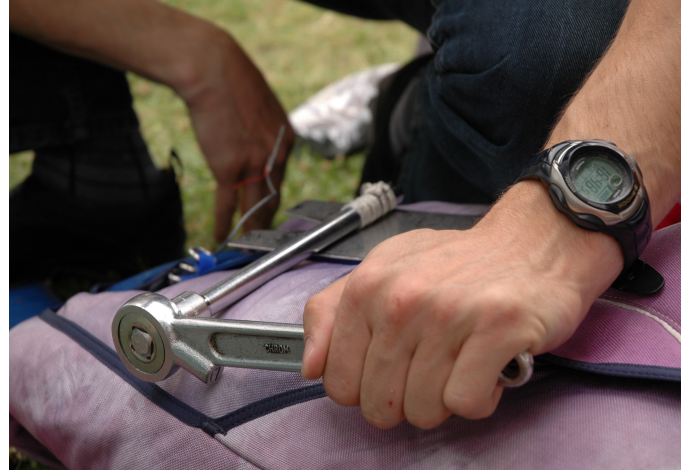
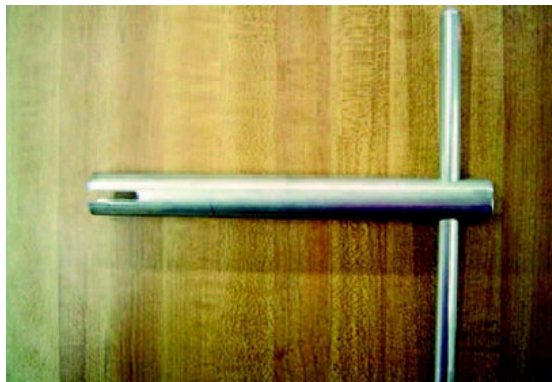
We would like to remind you that it is not allowed to use inadequate mechanical tools (force reduction systems) to close the reserve parachute. Those mechanical systems could implement a too important traction effort (above 10 daN maximum according to the TSO norms) to release the pin of the reserve parachute (see pictures #1, 2& 3 of Russian + South American + European Tools).

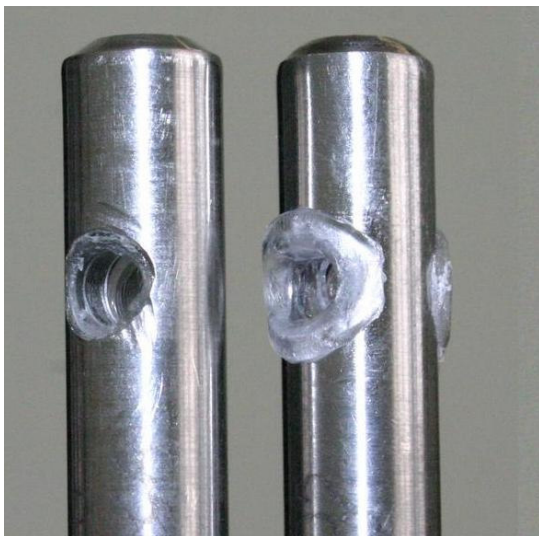
#4

The use of an inadequate mechanical system or the wrong placement of a temporary pin can cause the crushing of the cutter against the grommets or the temporary pin during the closing of the reserve (for example: using a temporary pin placed above the pilot chute, then placing the flap with the cutter and start traction on the closing loop with the temporary pin still in place). Those closing techniques could create such forces that the pressure between metallic grommets or pin could damage the plastic protection ring as even the stainless steel cutter body (see picture # 4).

A particular attention is requested to look carefully that the small plastic loop protection heads of the cutter(s) are not damaged during the repack of the reserve. If any degradation sign is detected on the plastic loop protectors, it is imperative to replace the cutter unit and the loop to avoid any reserve loop deterioration.

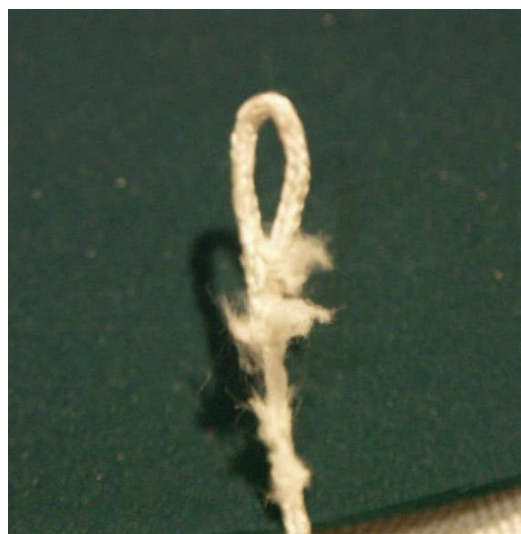
#5

Any damage of these plastic heads could provoke a deterioration of the reserve closing loop by friction during transport or use of the equipment. Those deteriorations could cause an inopportune opening of the reserve container (see picture #5).
