Mottagare: Kontrollanter, kontrollantelever, CI alla klubbar	Datum: 2019-10-09	BilagService Bulletin	Blad nr: 1 av 1
Fastställt av MK: 2019-10-09		Ersätter:	
Arenda: Materielvarning nr. 2019/2		Utfärdare: SFF Materielkommitté (MK)

**SERVICE
BULLETIN**

1. Issue Date : **September 30, 2016**
2. Bulletin number : **02/09/2016**
3. Subject : **m2 AAD Cutter Replacement**
4. Status : **Mandatory**
5. Identification : **Identification of affected m2 AAD cutters**

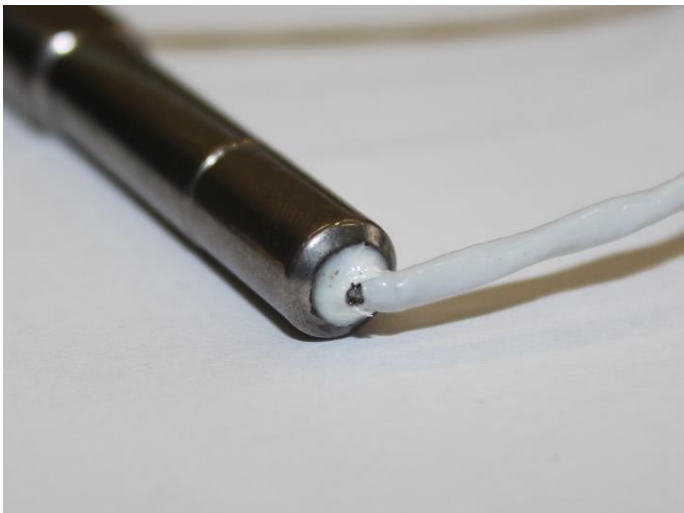
Fig.1

The cutter cable insulation has cracked on some MarS m2 AAD cutters as shown in Fig. 1. Investigation by the manufacturer has shown that this is caused by the method used to close and seal the cutter body. The cracking only affects the insulation, and the function of the device is unaffected. However, as a precaution, all cutters that are affected by this bulletin must be replaced.

a. If a problem exists with the cutter this will be detected by the control unit and displayed as an error No.2. In this case, the cutter must be replaced immediately.

b. If no error is detected, then the AAD may remain in use until the next repack cycle. During the next regular repack the cutter must be inspected and replaced if it is affected by this bulletin.

Mandatory before the next jump.

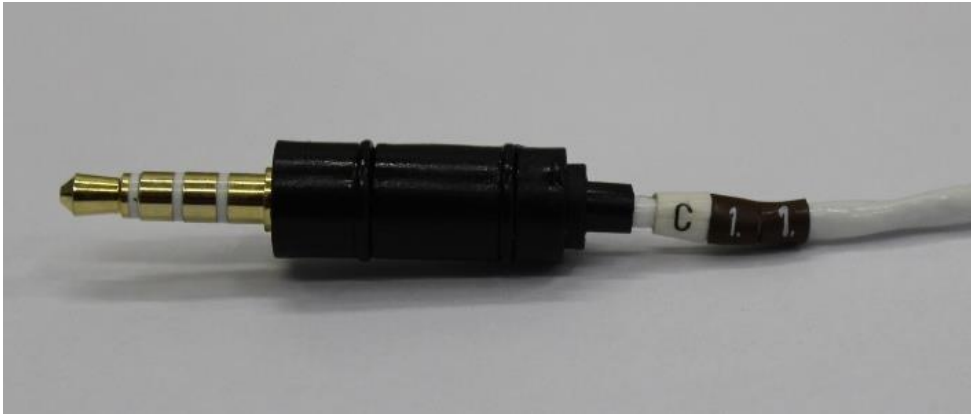
Fig. 2 Series C, year 2011 (marked on cutting unit cable)

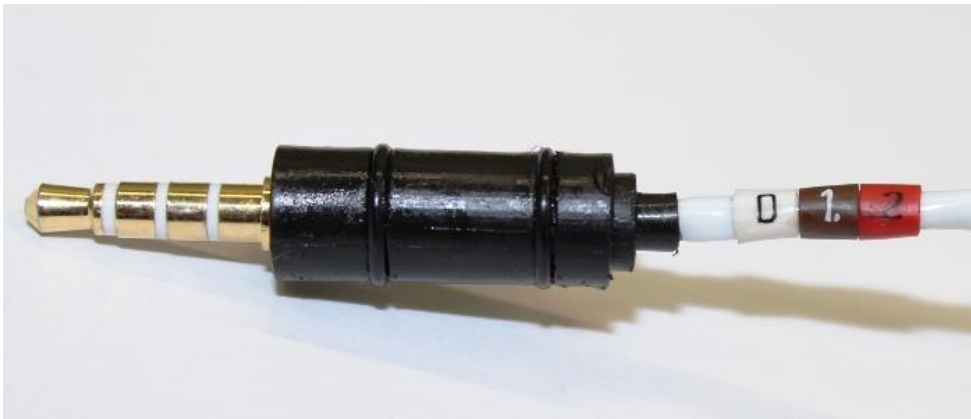
Fig. 3 Series D, year 2012 (marked on cutting unit cable)

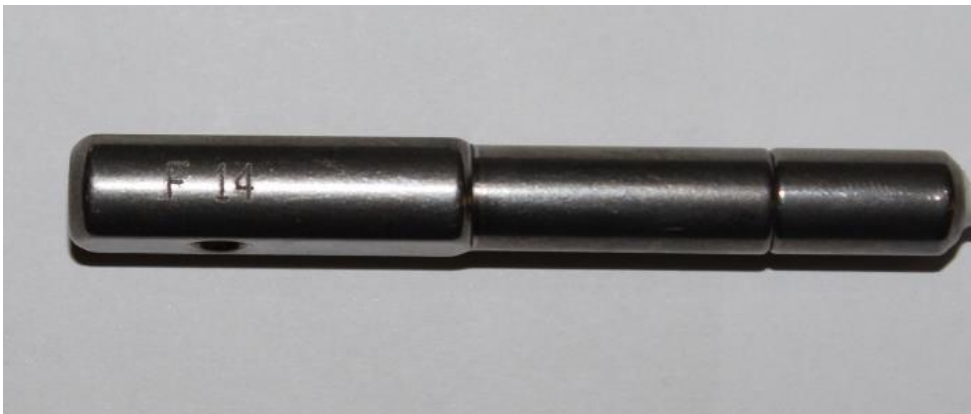
Fig. 4 Series F, year 2014 (marked on cutting unit cable)
