Mottagare: Kontrollanter, kontrollantelever, klubbar, MC Norden	Datum: 2020-09-16	Bilaga PIA PSB- 10092020	Blad nr: 1 av 1
		Ärende: Materielvarning nr. 1/20	
Fastställt av MK: 2020-09-16	Ersätter:	Utfärdare: SFF Materielkommitté (MK)

Product Service Bulletin

PSB Number: PSB-10092020

Identification: After-market Tandem Main Risers constructed with obsolete RW2 rings. All sport tandem main risers produced with RW2 rings, or equivalent sized rings, are affected regardless of the hardware manufacturer, the date of manufacture, the material type or the forging process used. This PSB does not affect “solo” main risers that use RW2 rings.

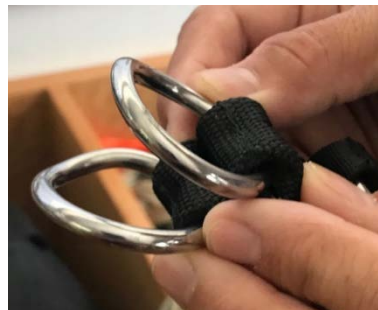
Figure-2

Background: Recent reports of “bent rings” on tandem main risers are of great concern. At least one after-market manufacturer of obsolete and unapproved tandem risers is using RW2 rings or similar rings, which were discontinued for tandem use in 1996 due to “bent ring” issues. These rings pass a proof load of 500 lbs. and begin to distort at 2500 lbs.

Two (2) sets of tandem risers were recently discovered with bent rings. This pair bent after one (1) jump; a second pair had approximately 30 jumps.

Compliance: **MANDATORY** – REPLACE BEFORE THE NEXT JUMP.

RW2 rings (or similar size rings) have a cross-section thickness of less than 5mm (0.197"). Risers with these dimensions should be permanently grounded for tandem use.

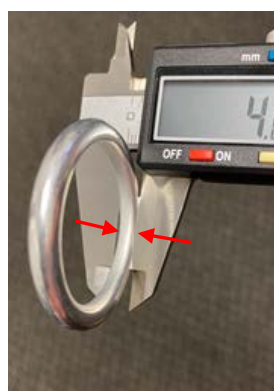
Figure-3

Use a digital caliper to accurately measure the cross-section thickness of the ring. Refer to *Figure-3* below for proper caliper/ring interface while measuring. The riser should be disconnected from the harness base ring to accurately obtain a measurement.

Cross-section Thickness
RW2 Ring: 4.75mm (0.187")
RW11 Ring: 5.74mm (0.226")

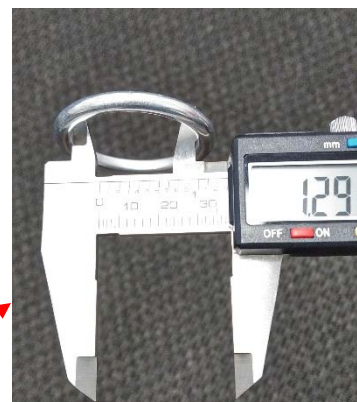
Figure-4

Inner Diameter
RW2 Ring: 32.9mm (1.30")
RW11 Ring: 31.0mm (1.22")

The inner diameter ring dimensions are also provided (*Figure-4*) as further verification of the ring type.
