Dnr SFF-2019-16

INVESTIGATION REPORT SKYDIVING ACCIDENT 2-2018

Fatal skydiving accident July 26, 2018

Datum: **2020-01-24**

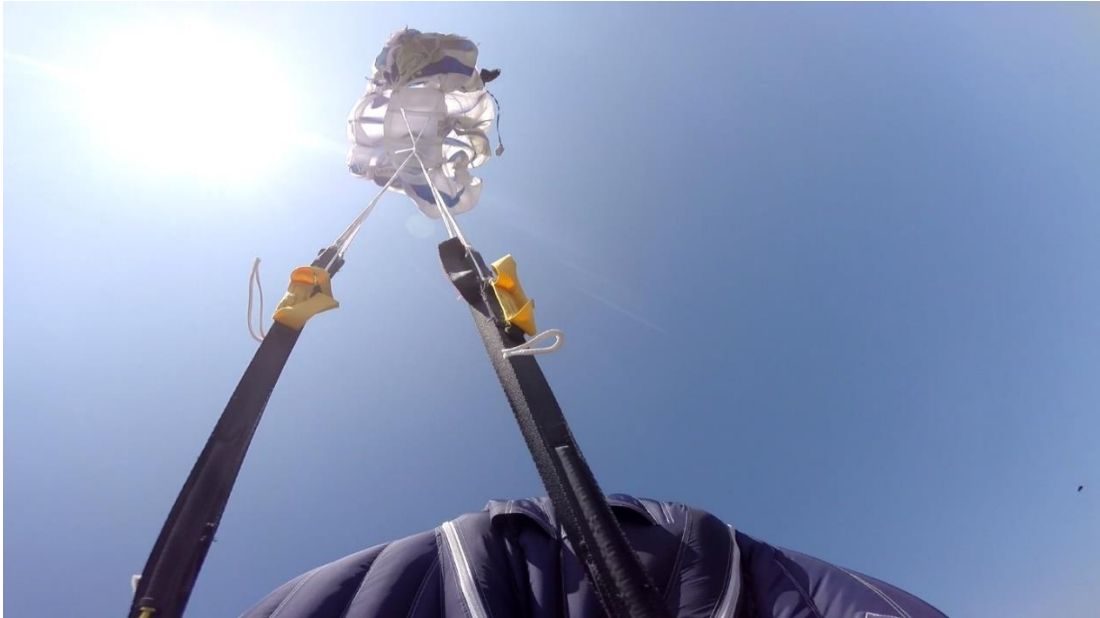
1.5.5.1 RB experiences a malfunction on the main parachute; line twists, picture 1.

Picture 1. Main parachute with line twists immediately after the pull.

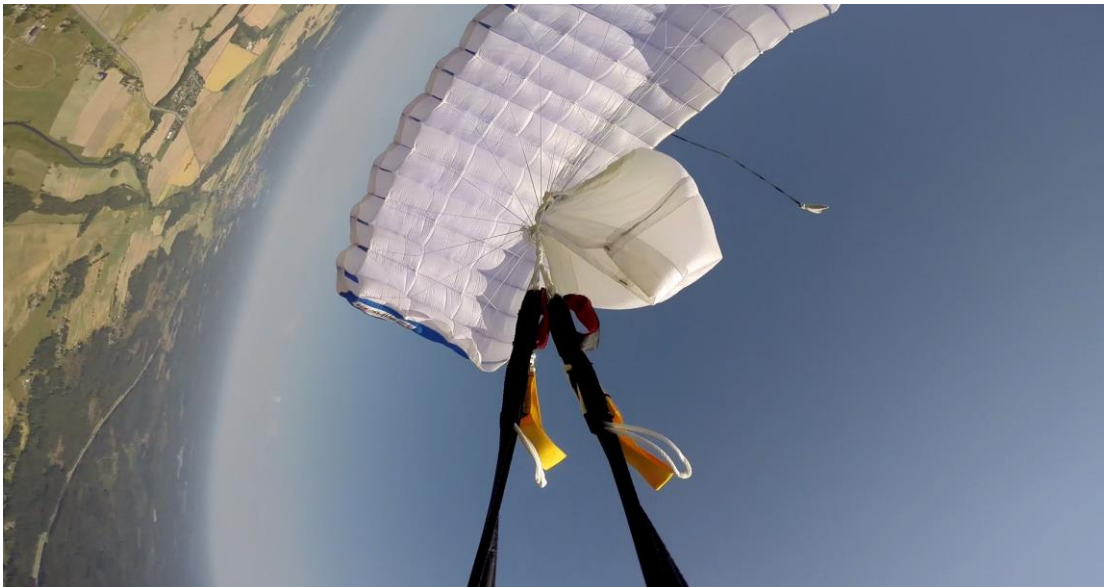
1.5.5.2 RB gets a strong rotation clockwise due to the malfunction, picture 2.

Picture 2. Main parachute with line twists approx. 10 seconds after pull.

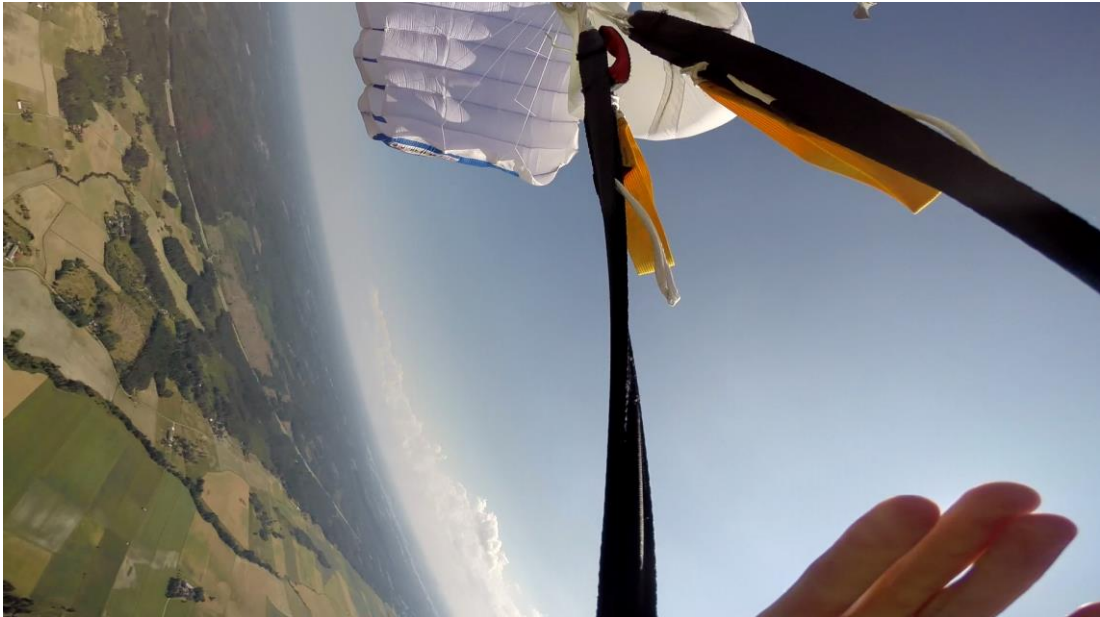
1.5.5.5 RB tries to solve the line twists, picture 3-4.

Picture 3. Attempts to untwist the lines.

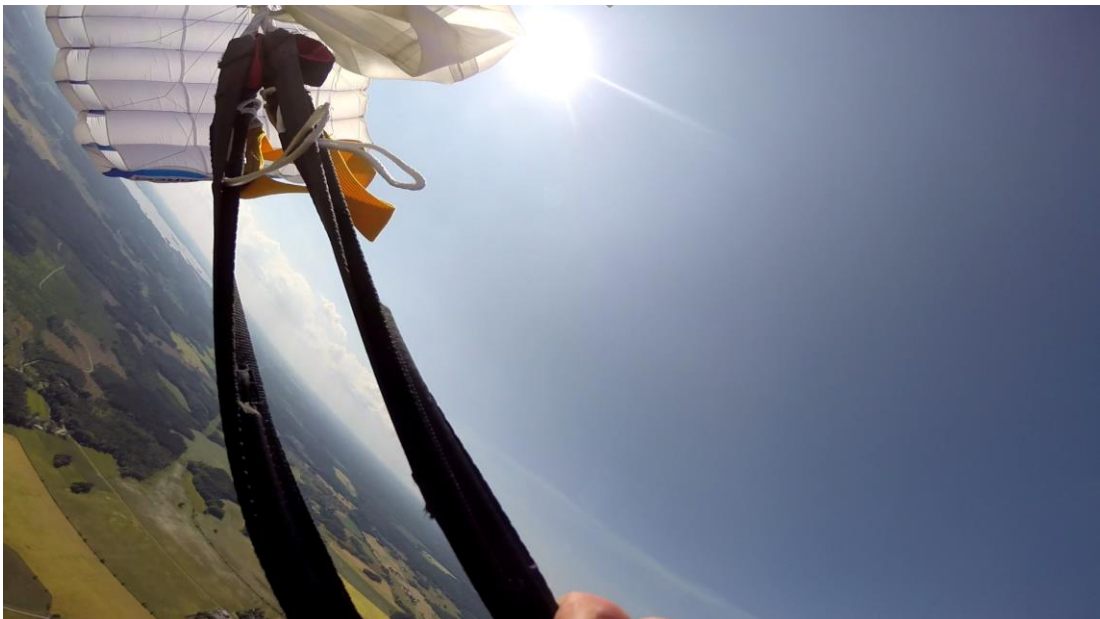
Picture 4. Attempts to "unwind" the twist.

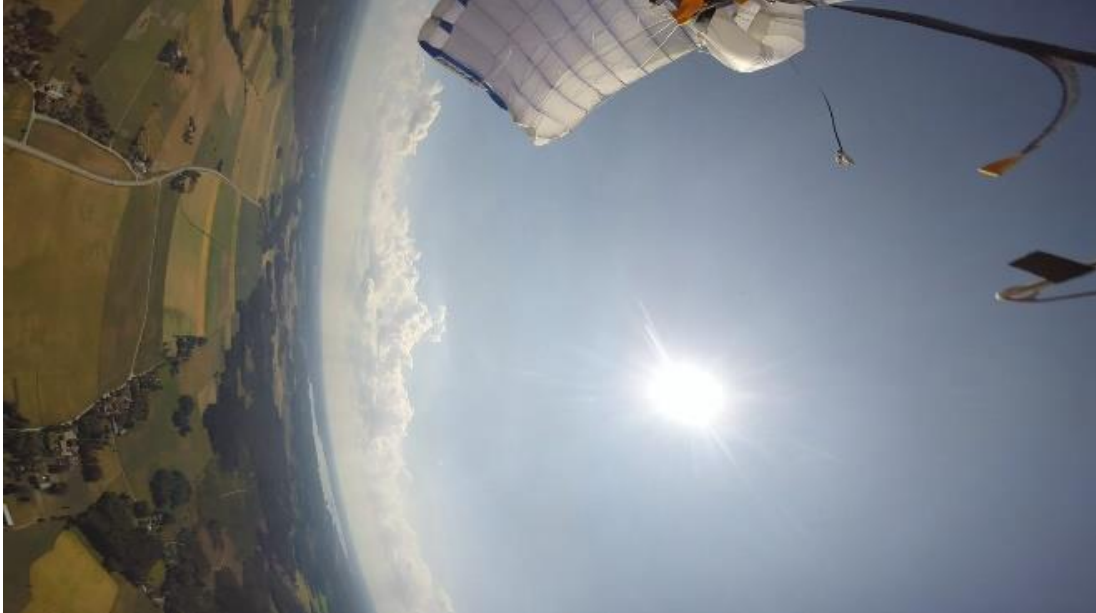
Picture 5. After cutting away the main parachute. The reserve pin is visible to the right.

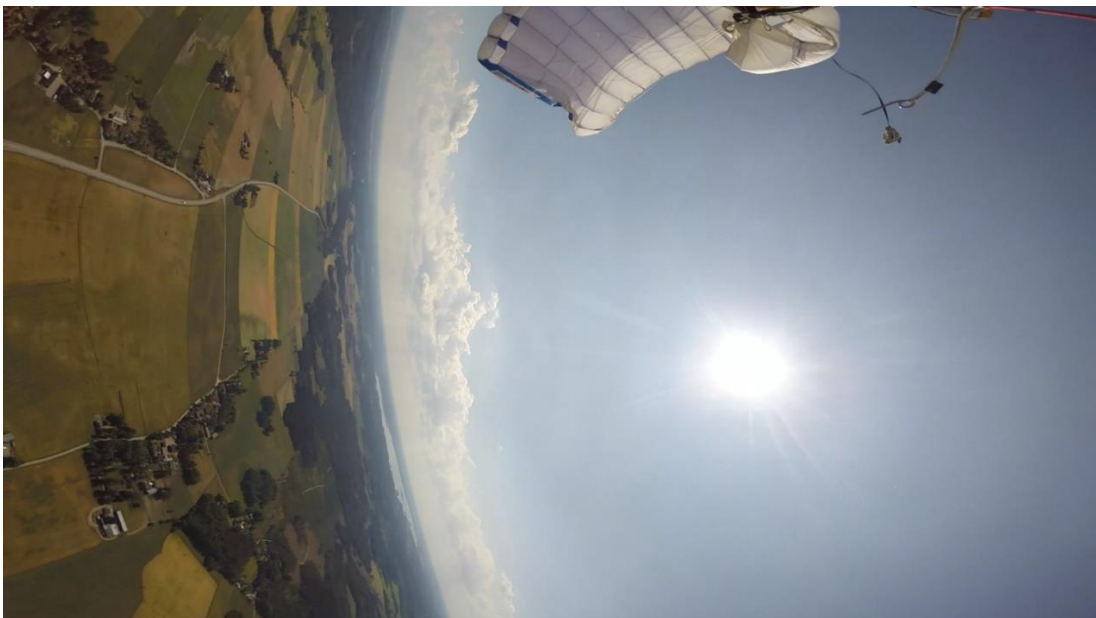
Picture 6. The main parachute with the Skyhook pulls the reserve pilot bridle. The Red Skyhook Lanyard is tense (upper right corner).

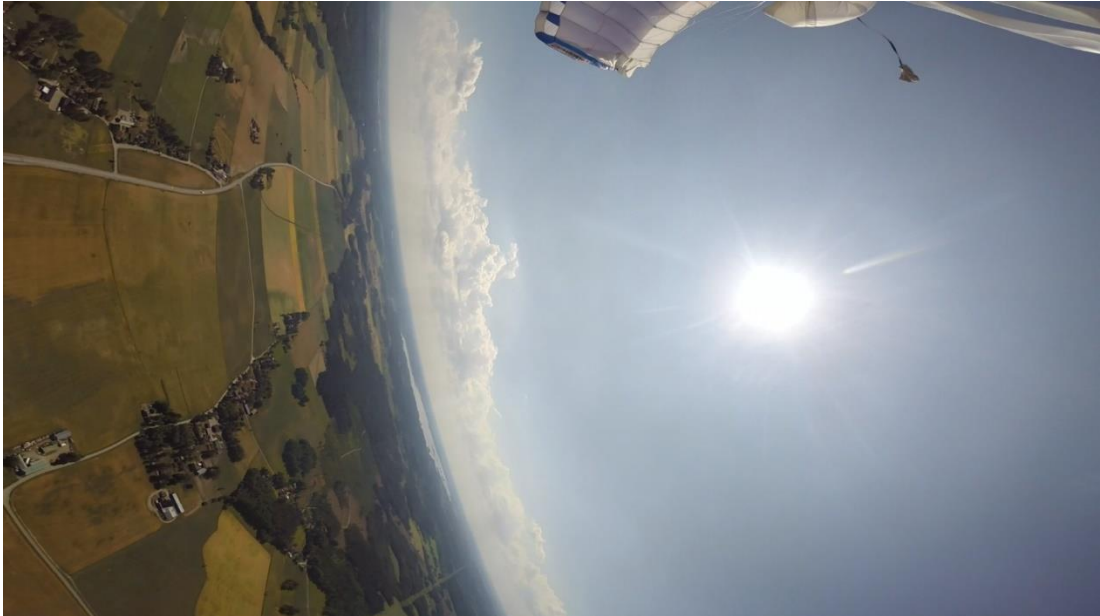
Picture 7. Bridle of the reserve parachute pilot is stretched. The Skyhook is still pulling.

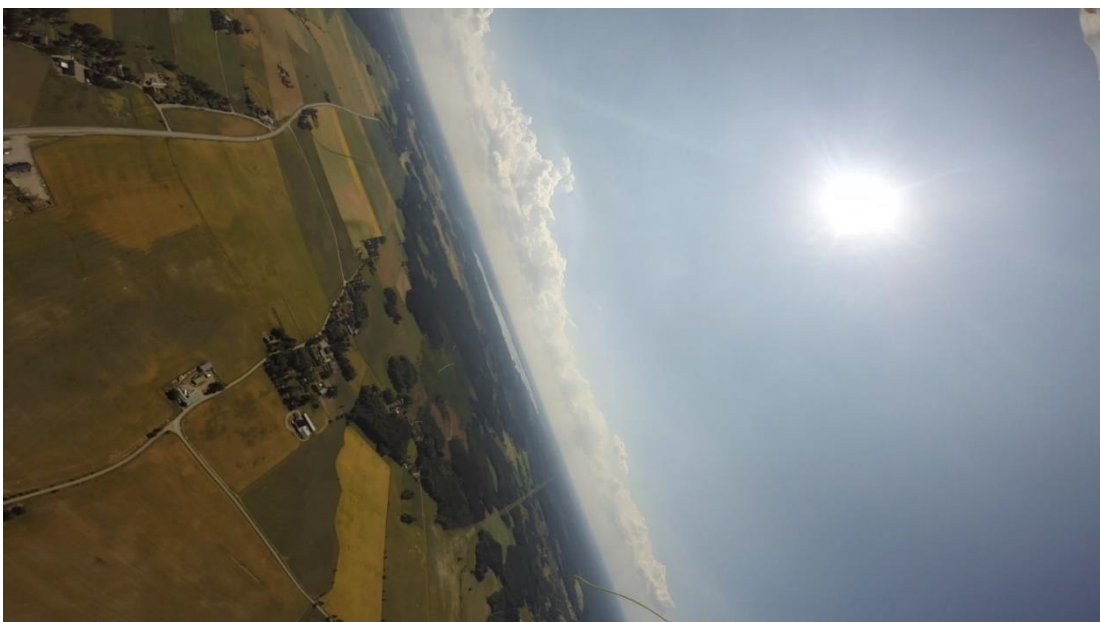
Picture 8. The Skyhook has disconnected. (The reserve parachute pilot bridle is not stretched).

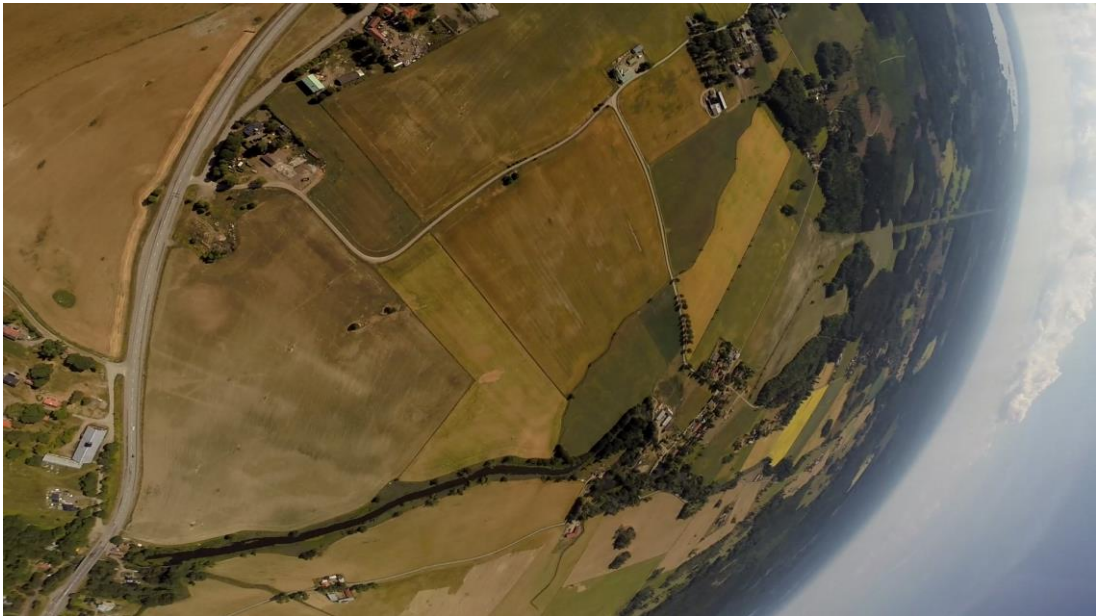
- 1.5.6.5 RB ends up in an oblique diving body position with his left shoulder down, which turns to a skewed front flip to back position. The flip is completed diagonally over the right shoulder, see picture 9-13.

Picture 9. RB in diving body position with left shoulder down.

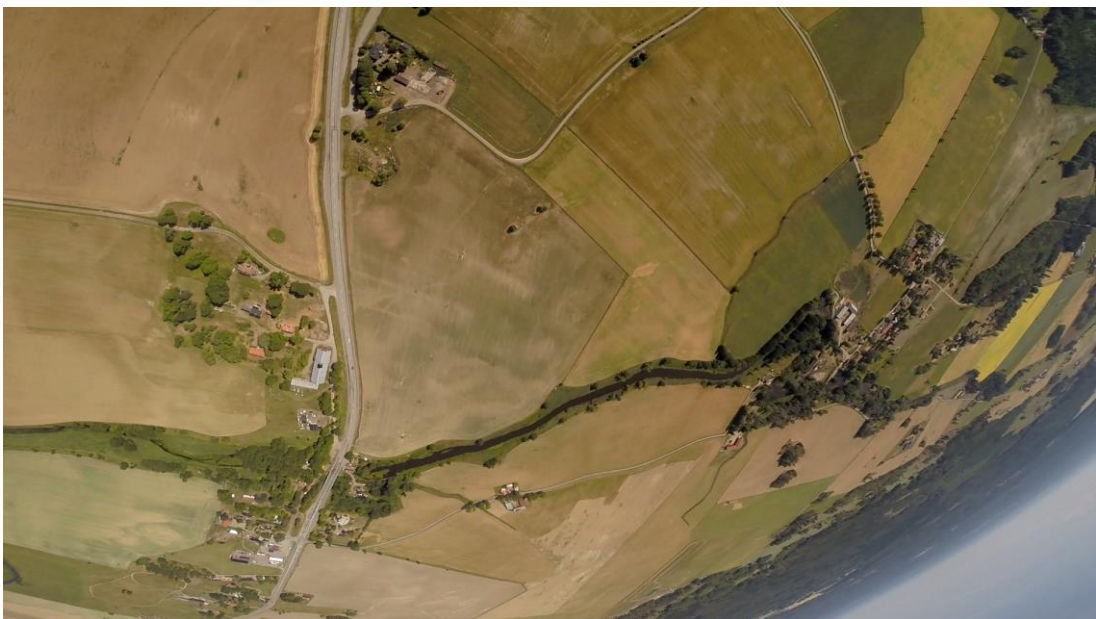
Picture 10. RB in back position during front flip.

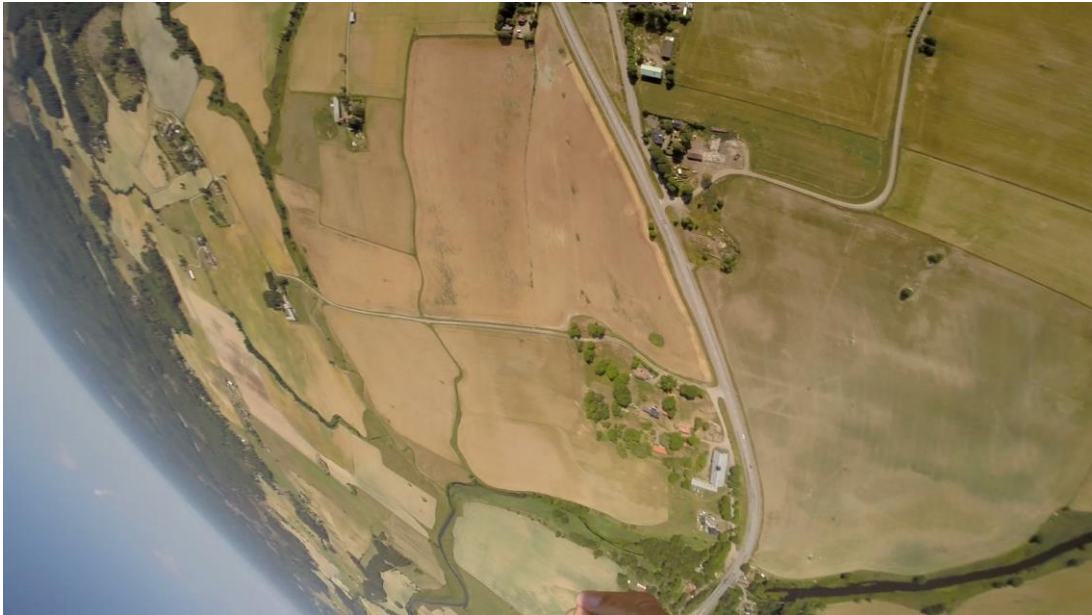
Picture 11. RB in front flip diagonally over the right shoulder.

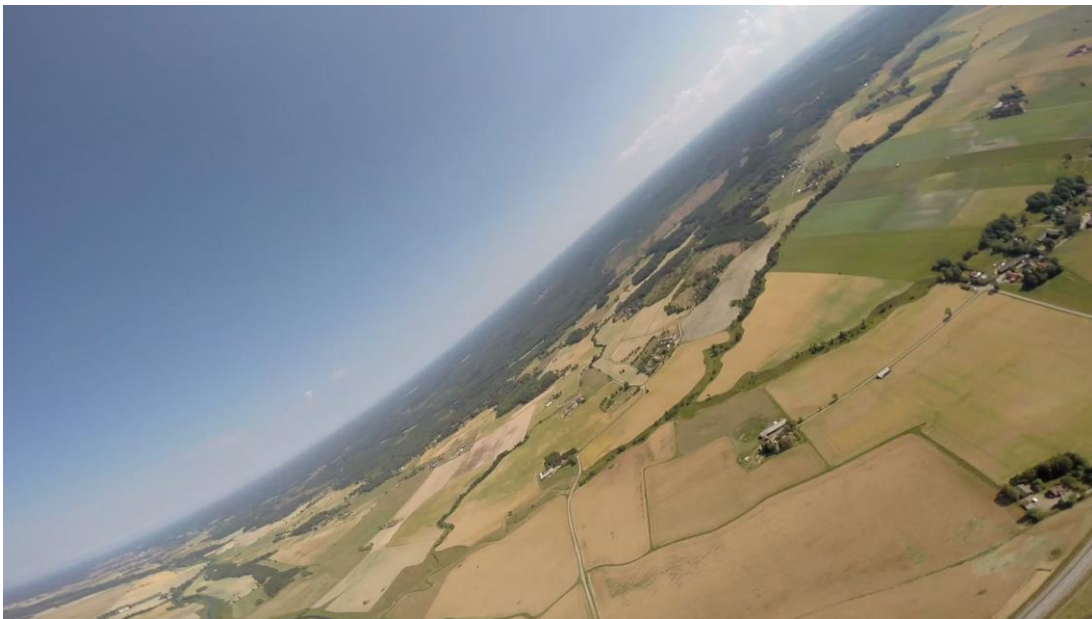
Picture 12. The flip is completed.

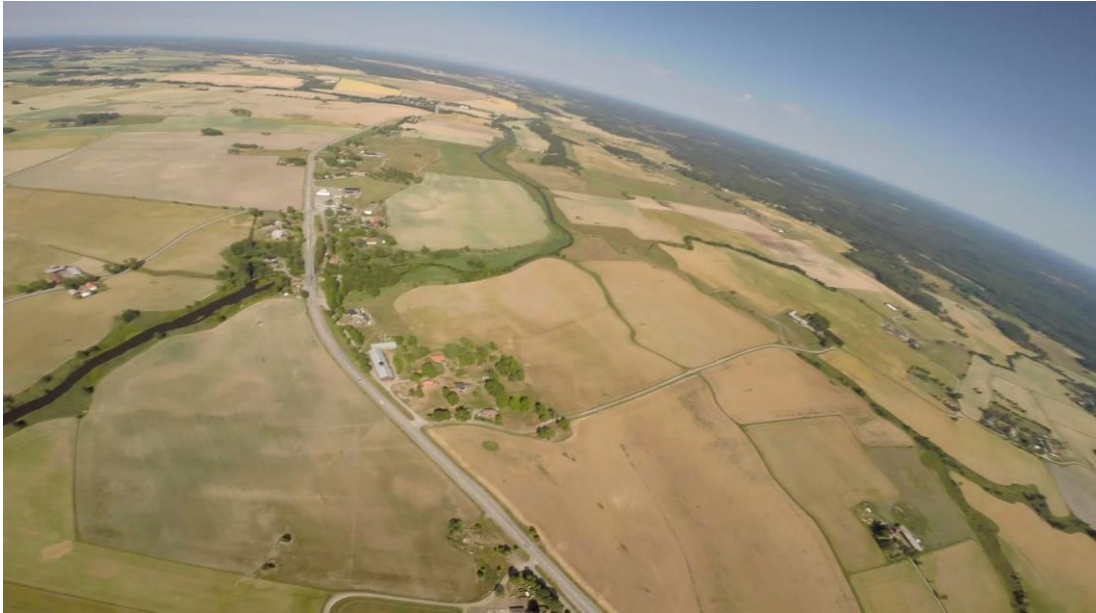
Picture 13. The front flip is completed.

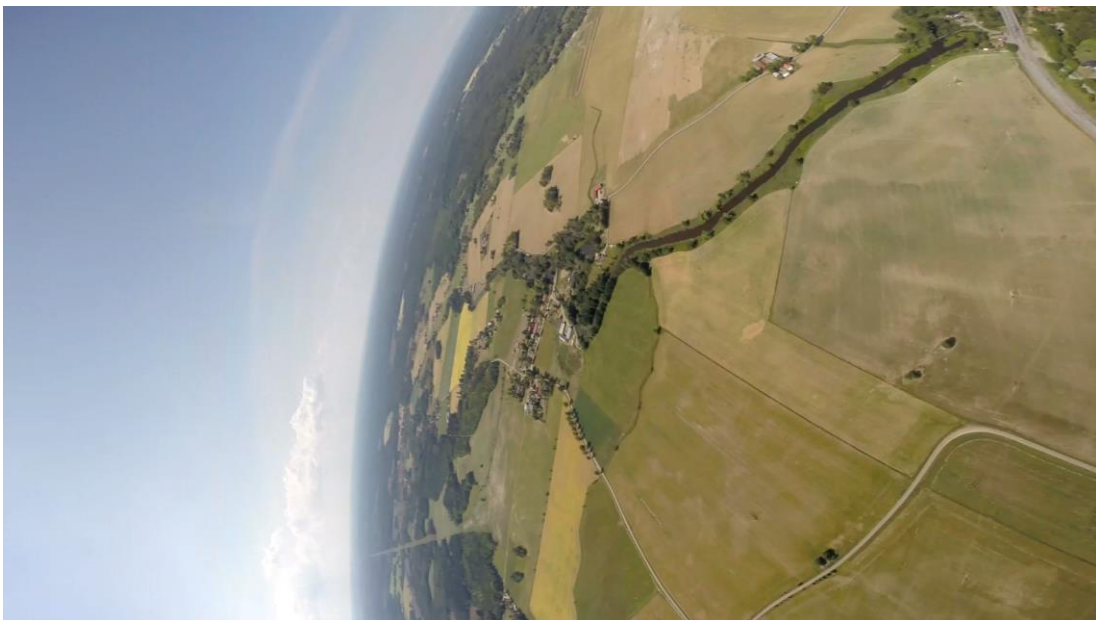
Picture 14. RB is quickly turned from horizontal position to a right position.

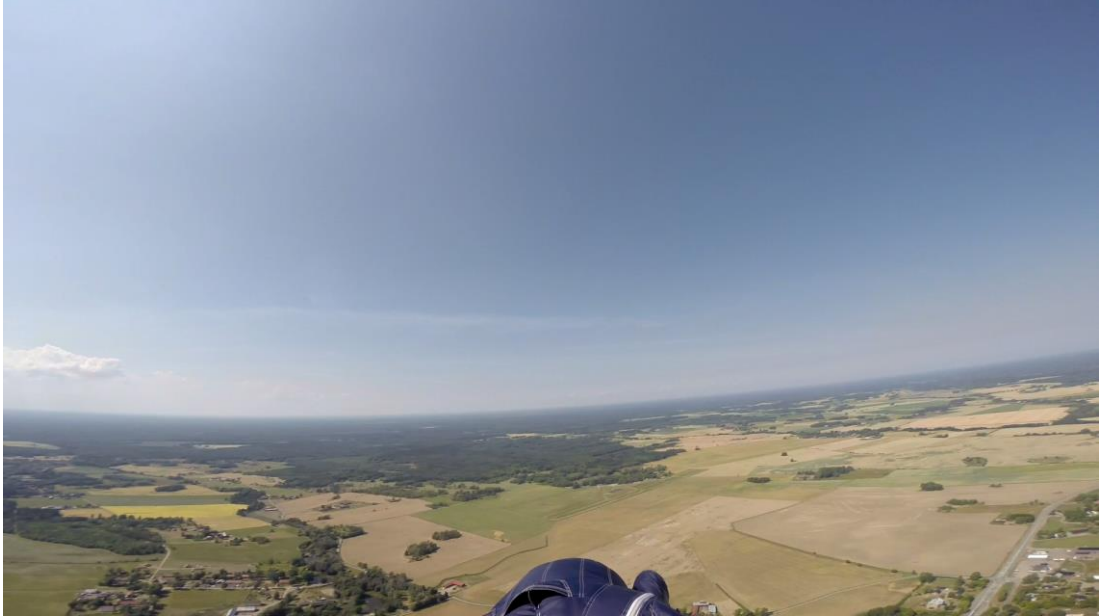
Picture 15. RB straightened up to vertical position

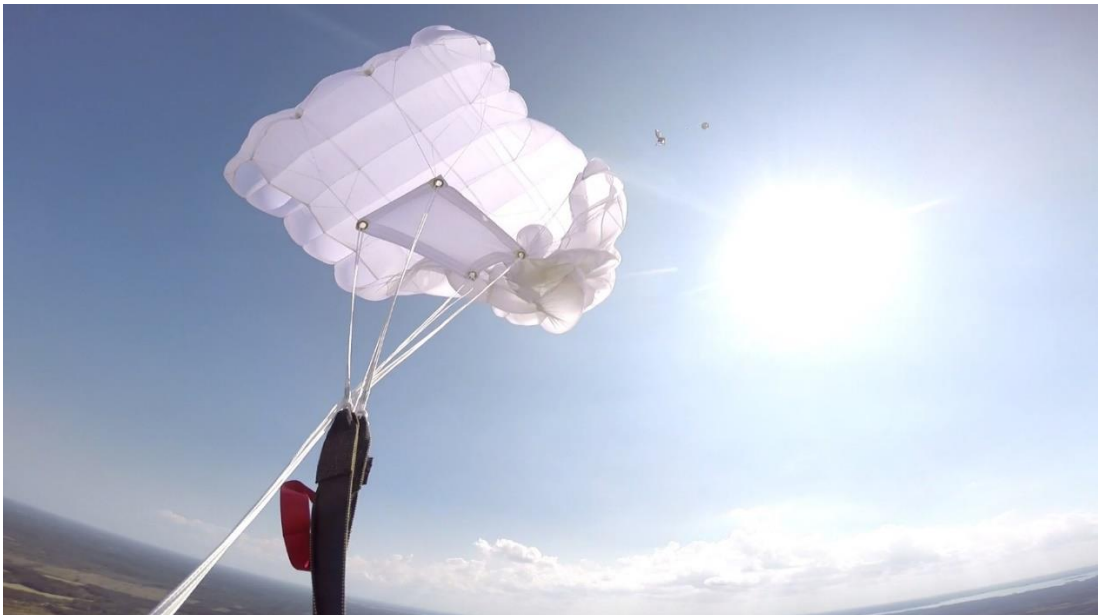
- 1.5.7.3 The reserve parachute malfunctions during the development process, resulting in an incomplete developed canopy and line twists, see picture 16-18.

Picture 16. The reserve parachute immediately after opening. Above the reserve, the cut away main parachute and freebag. Note! Only the left risers are visible.

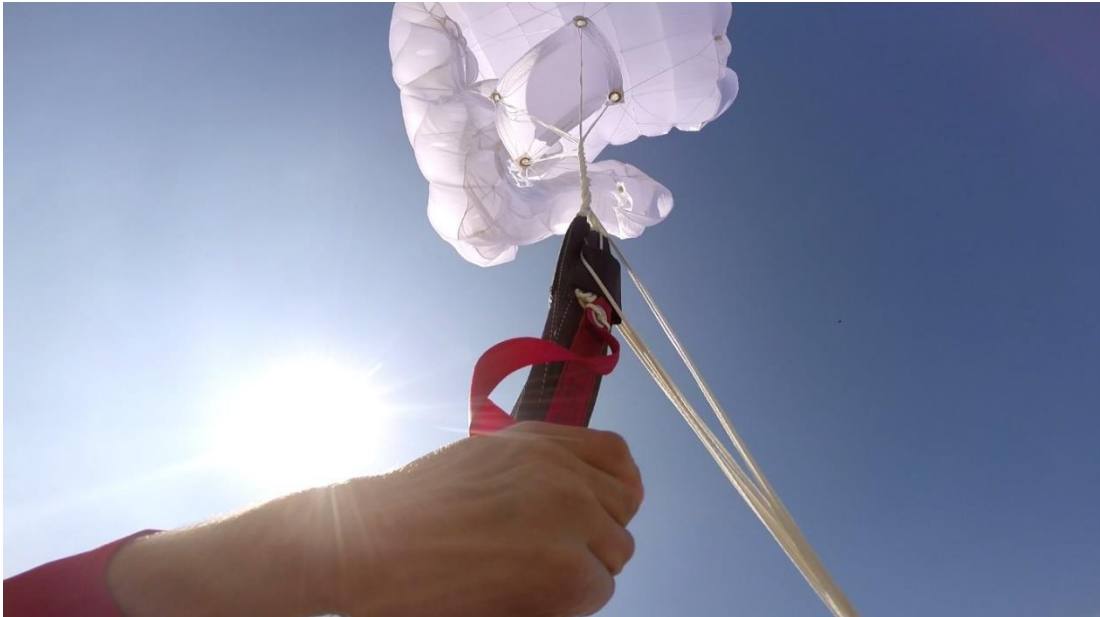
Picture 17. The reserve parachute incompletely developed and with line twists approx. 10 seconds after opening. Only the left risers are visible. The lines on the right side go down to the right risers below the image.

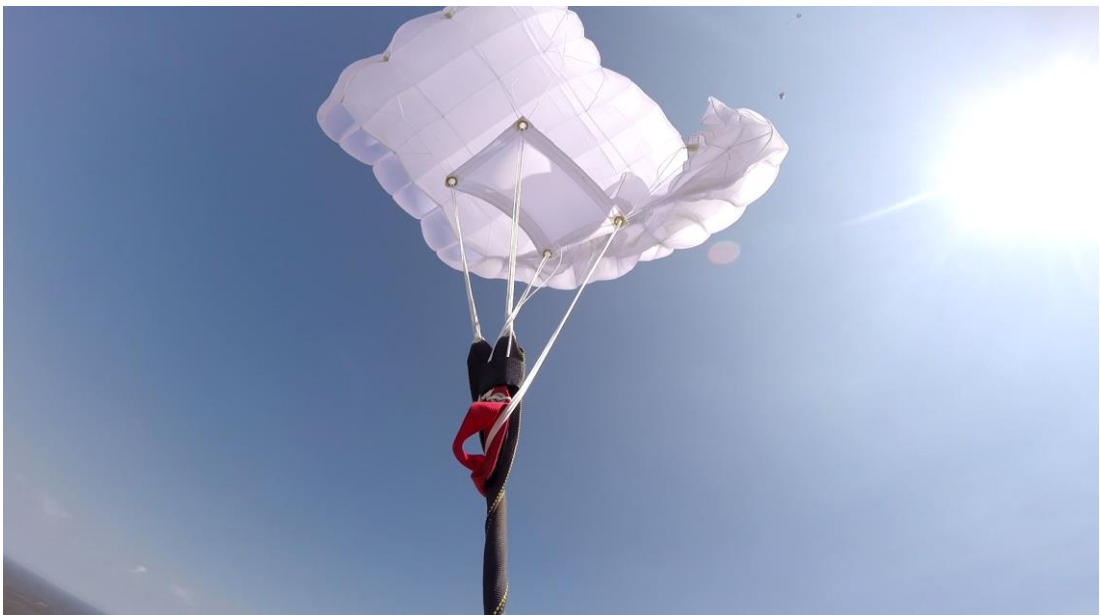
1.5.7.4 The malfunctioned reserve parachute with only 3 out of 7 cells fully inflated, picture 18.

Picture 18. The reserve parachute with 3 cells out of 7 fully inflated.

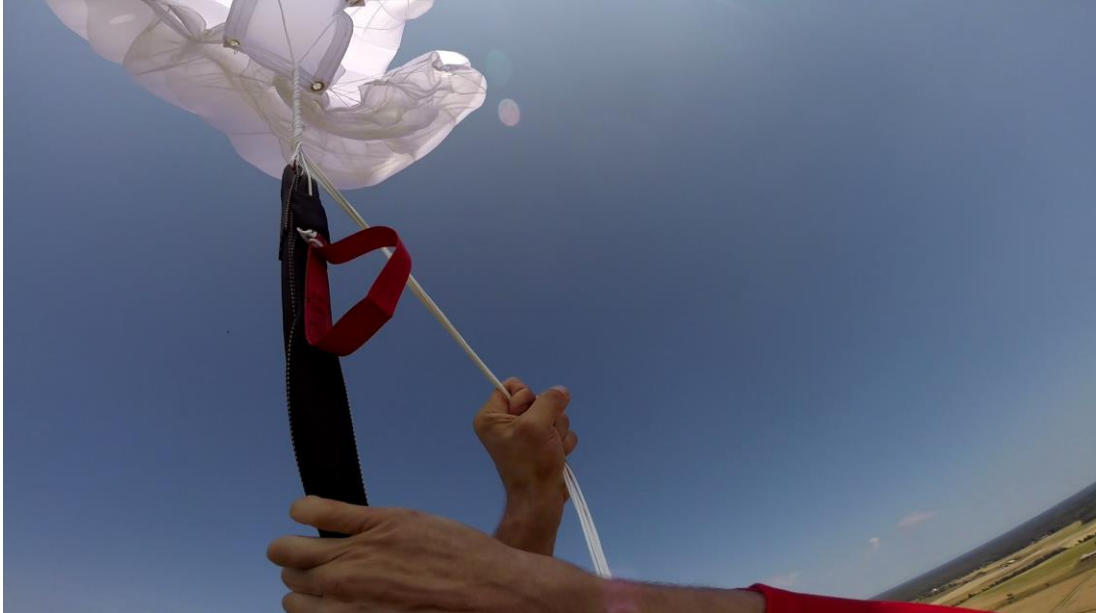
1.5.7.5 RB pulls the right suspension line group outwards and down, pictures 19-20.

Picture 19. RB pulls the right suspension line group outwards and down.

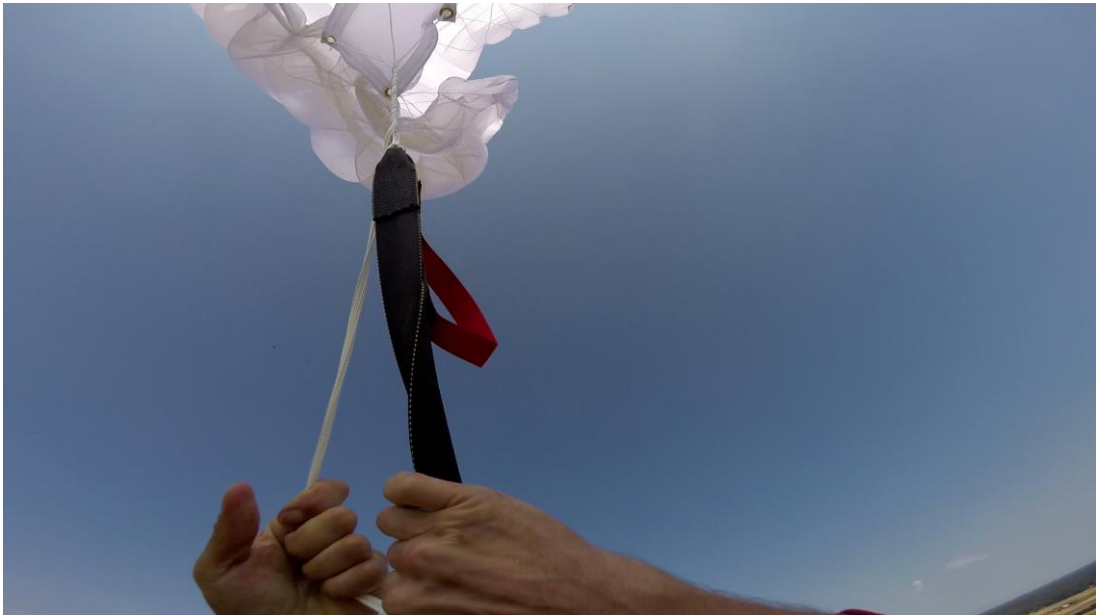
Picture 20. RB pulls the right suspension line group outwards and down.

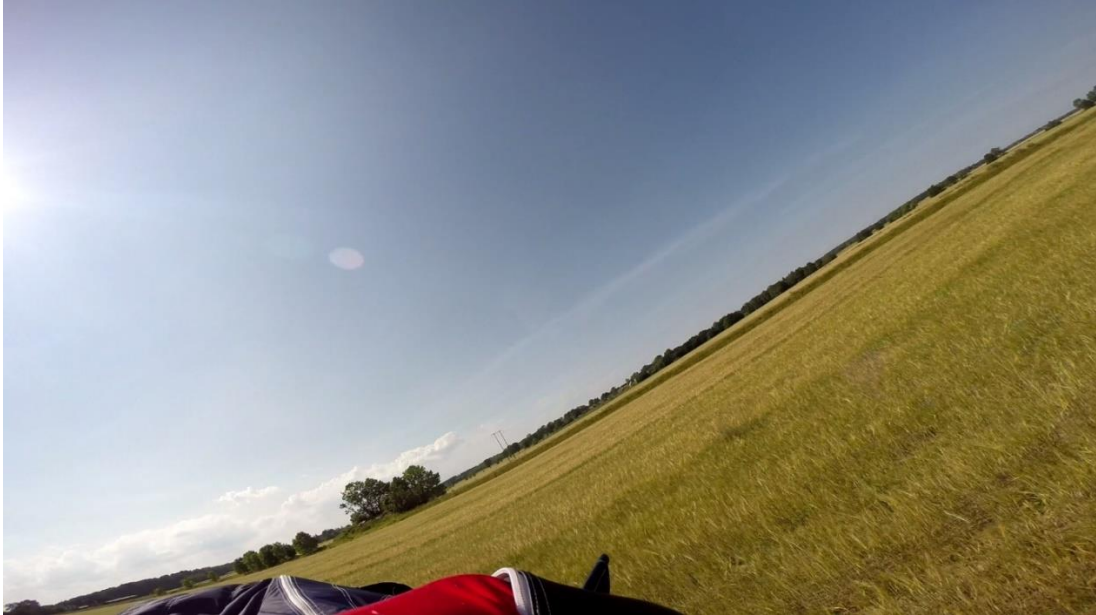
1.5.8.1 RB hits the ground at high-speed spinning/rotating with the back first and the body stretched in the direction of rotation, picture 21.

Picture 21. RB in a back to earth position stretched out by the rotational force immediately before impact.
