Mottagare: Kontrollanter, kontrollantelever, klubbar	Datum: 2021-09-22	Bilaga Firebird PSB FB 2021-01	Blad nr: 1 av 1
Fastställt av MK: 2021-09-22		Ersätter:	Ärende: Materielvarning nr. 2021/2
		Utfärdare: SFF Materielkommitté (MK)

PRODUCT SERVICE BULLETIN

Bulletin Number: FB 2021-01

SUBJECT: Firebird V1R1 EVO Harness container systems with adjustable Main Lift Web

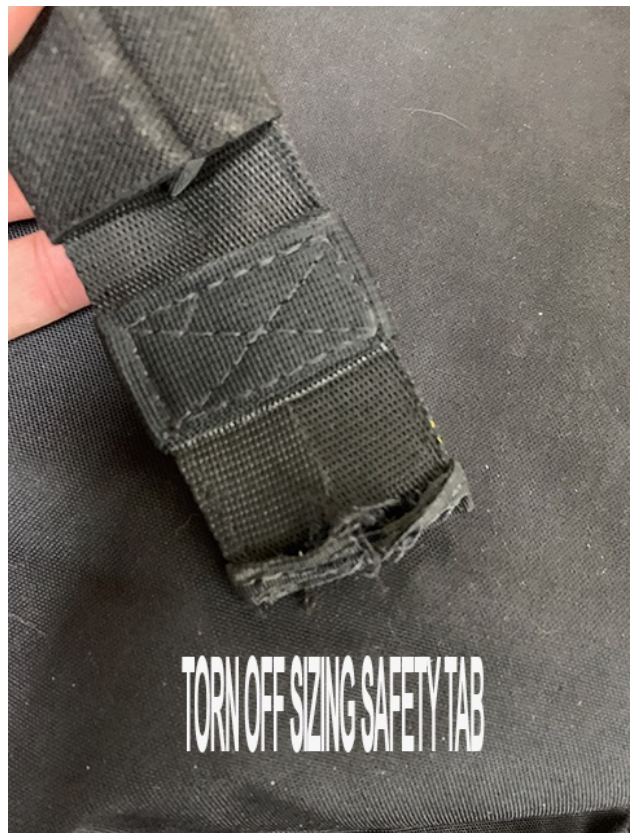
Right Main lift web undone, sizing safety tab ripped off and stuck under a stretched but intact sizing tab retainer (1/2" type 1), 555-2 ring installed **correctly**, **missing** spring, **NO** damage to type 4 stopper.

In this incident, it appears that, the only thing that kept the webbing from coming undone, was the engaged sizing safety tab in the type 1 sizing tab retainer and that it subsequently broke under the load of the opening as **zero** damage to any other component occurred.

The right main lift web of the affected container that came undone does **not** show any damage on the type 4 stopper with only the sizing safety tab torn off and matches only the findings of at least one configuration of those simulations carried out by Firebird.

Torn off tab, damage free type 4

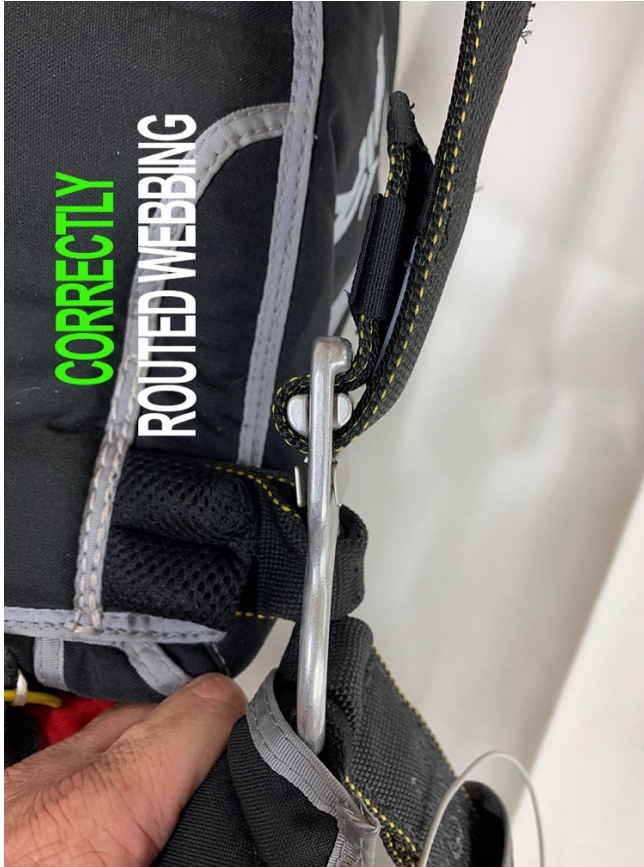
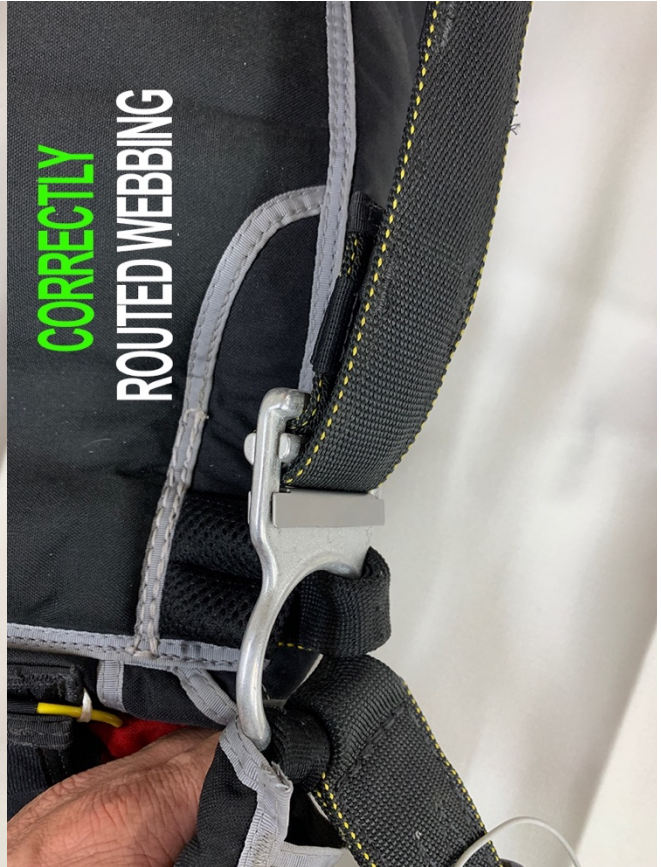
!!!! CORRECT ROUTING !!!!

Correctly routed webbing, **regardless** of the ring direction, showed **zero** slippage or damage.

Therefore, we mandate a visually inspection before the next jump, to confirm the correct routing of the adjustable main lift web through a type 555-2 ring (DJA/CWH) especially if the container has been disassembled for repairs, maintenance, cleaning, or any other reason. All direct customers have been contacted by Firebird USA LLC.
