Mottagare: FSK-tekniker		Datum: 2023-01-28	Bilaga Service bulletin No.: 01/04/2022 Rev. C	Blad nr: 1 av 1
		Ärende: Materielvarning FSK-tekniker nr. 2023/1		
Fastställt av MK: 2023-01-28	Ersätter:	Utfärdare: SFF Materielkommitté (MK)

SERVICE
BULLETIN

Service bulletin No.: 01/04/2022 REV. C
Number of pages: 2
Number of annexes/pages: 1 / 1

1. Issue Date : **April 8, 2022**
2. Bulletin number : **01/04/2022 REV. C**
3. Subject : **ATL-15 SL (ATL-88/90-1B)**
4. Status : **Mandatory**
5. Identification : **Identification of affected ATL-15 SL (ATL-88/90-1B)**

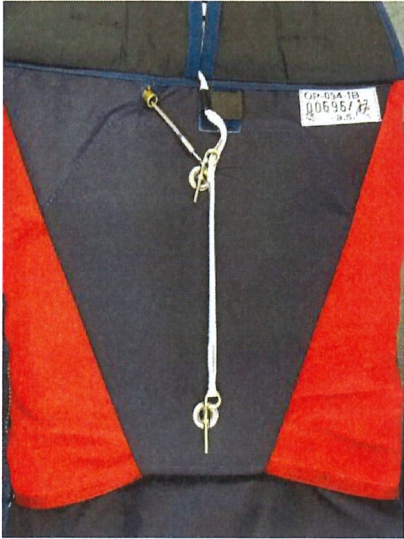
During the yearly inspection of one of the affected emergency parachutes, it has been found that the length of the ripcord between the pins was too large and, in some cases, only one of 2 loops of the parachute could be opened when the manual ripcord was pulled. Subsequent inspection revealed that the dimensions of the static line extension were out of production tolerances.

Photo 1., The status before adjustment

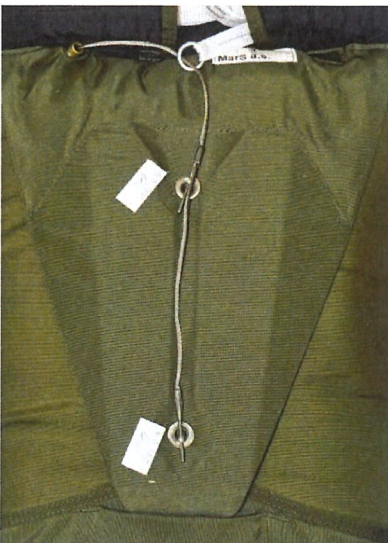
Photo 2., The status after adjustment

- a. Affected emergency parachutes send to the manufacturer MarS a.s. for making adjustments.
- b. Manufacturer MarS a.s. makes adjustments as follows:
 - replacing one container cover flap without shaping for new cover flap with shaping according to Change No.: 03/22;
 - replacing Ripcord with eye for Ripcord with two pins according to Change No.: 03/22;
 - replacing Static line with the Extension of Static Line made of Microline cord for Static line with metal ring according to Change No.: 03/22;
