Mottagare: Kontrollanter, kontrollantelever, klubbar, MC Norden, HL	Datum: 2004-01-07	Bilaga SB PdF #2/2003	Blad nr: 1 av 1
	Ärende: Materielvarning nr. 1/04		
Fastställt av MK: 2004-01-07	Ersätter:	Utfärdare: SFF Materielkommitté (MK)

”Safety bulletin” nr. 2/2003, daterad 19 december 2003, från Parachutes de France.

**SAFETY BULLETIN**

N°2/2003  
Date: 19/12/03  
Pages 2/2

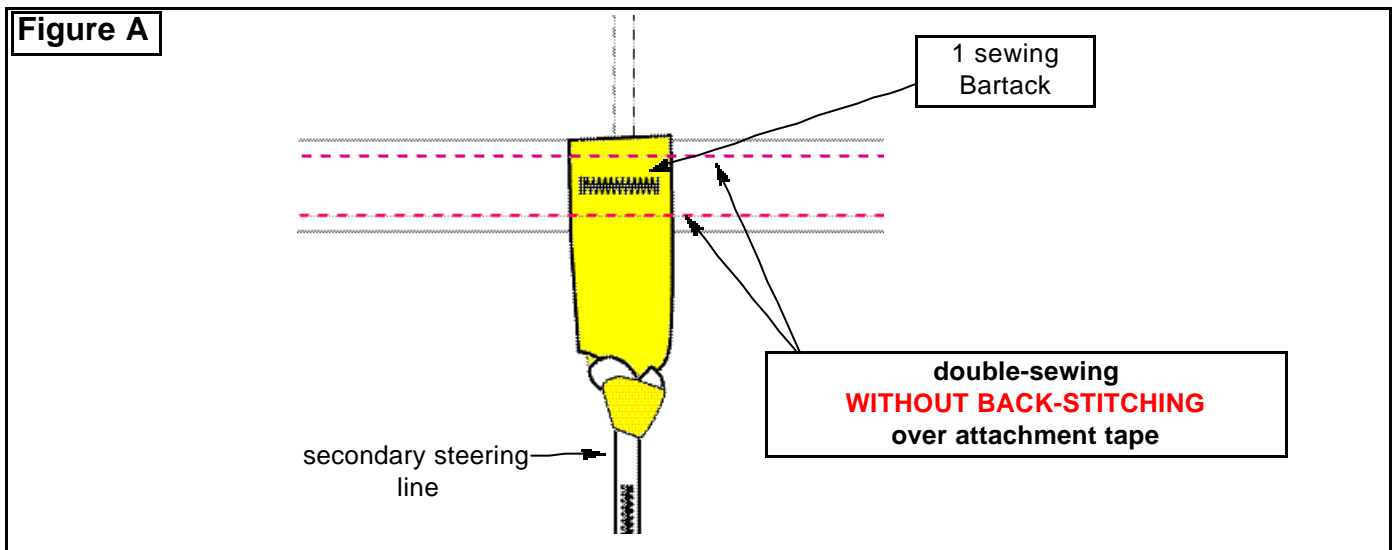
Broken seams located at secondary steering lines trailing edge attachment tapes have been reported on reserve canopy model Minimax 5 (Pn:203).

The assembly of steering lines attachment tapes to trailing edge of the concerned canopy is described by Figure A.

The manufacturing process described Figure A have potentially been used for all others reserve canopies of Parachutes de France from january 1987 to february 1989.

Berörda fallskärmar är groundade till dom inspekterats. Om den tillverkningsmetod som visas i bifogad säkerhetsbulletin har använts för att fästa styrlinorna i kalottens bakkant är kalotten även fortsättningsvis groundad. Kalotter som är berörda av säkerhetsbulletinen men där den beskrivna infästningsmetoden *inte* har använts får åter användas efter inspektion.

- 1- Detailed inspection by qualified rigger of all stitching pattern at trailing edge for steering lines attachment tapes.
  - Pattern per Figure A as above: immediate grounding even if stitching or fabric are fully undamaged
  - Others stitching patterns: unless damaged, airworthiness is not affected
- 2- Record riggers marks on canopy documents, with "BS PdF N°3-2003, Airworthy" or "BS PdF N°2-2003, Grounded".
- 3- Report to PF S.A. using second page of present Safety Bulletin.
