Mottagare: Kontrollanter, kontrollantelever, klubbar, MC Norden, HL	Datum: 2011-11-02	Bilaga	Blad nr: 1 av 1
		Ärende: Materielvarning nr. 3/2011	
Fastställt av MK: 2011-11-02	Ersätter:	Utfärdare: SFF Materielkommitté (MK)

**EMERGENCY PRODUCT SERVICE BULLETIN**  
**(Supersedes Product Service Bulletin PSB-7)**

**Bulletin Number** : PSB-8

**Subject** : Vigil Cutters

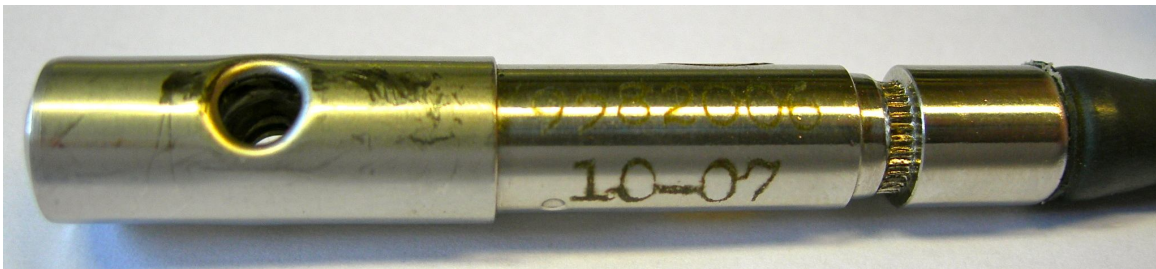
**Photo 1**

Vigil AAD, All Cutters produced in October 2007  
Part Number: 9582006  
Date of Manufacture: 10-07 (mm-yy)  
(See Photo 1.)

**The cutter was part of a production batch of 299 pieces, produced in October 2007. (See Photo 1.) In the interest of safety, AAD has decided to recall all cutters from the October 2007 cutter batch and to replace all of those cutters free of charge.** The removed cutter must be returned to AAD sa/nv or Vigil USA, LLC once the replacement cutter has been received. (Please contact AAD sa/nv or Vigil USA, LLC for return information and instructions.) This will enable us to personally examine and analyze as many cutters as possible from this batch in order to verify that this, in fact, has been an isolated incident.

**DOM : October 2007**

Even though the production batch only included 299 pieces, Vigil has identified additional Vigil serial numbers (see list B), from those stated in PSB-7 (see list A), on which the affected cutters might have been installed and has included the additional Vigil serial numbers in this PSB-8. The list provided in this PSB-8 replaces the previous list and must be used for reference, however it is essential that any cutter with a Date of Manufacture ("DOM") of 10-07 be replaced, regardless of whether or not the Vigil serial number is on the list.

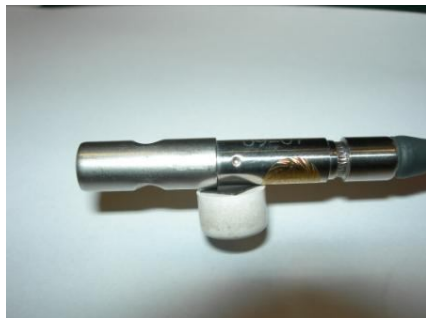
In the interest of additional safety, we have devised a field test, which can be performed on any Vigil cutter, using a magnet to confirm the presence or lack of a knife blade. It can be done using any magnet on any cutter. Either a small (see Photo 2A) or a larger (see Photo 2B) magnet may be used. You must ensure that the magnet is placed directly below the closing loop hole portion of the cutter, as shown in Photos 2A and 2B. If there is a knife blade present, the magnet will be attracted to the knife blade. If you require a magnet they are available on request from AAD sa/nv or Vigil USA, LLC.

Photo 2  
Magnet Test Procedure

Note: All Cutters manufactured from June 2008 have been x-rayed as part of our quality control process, and we have confirmed that the knife blade is present, however for additional safety, we highly recommend that the magnet test be performed on each cutter manufactured prior to June 2008.
